**Assessment of liquefaction and related ground  
failure hazards in Palmerston North, New Zealand**

**GNS Science Consultancy Report 2011/108  
July 2011**

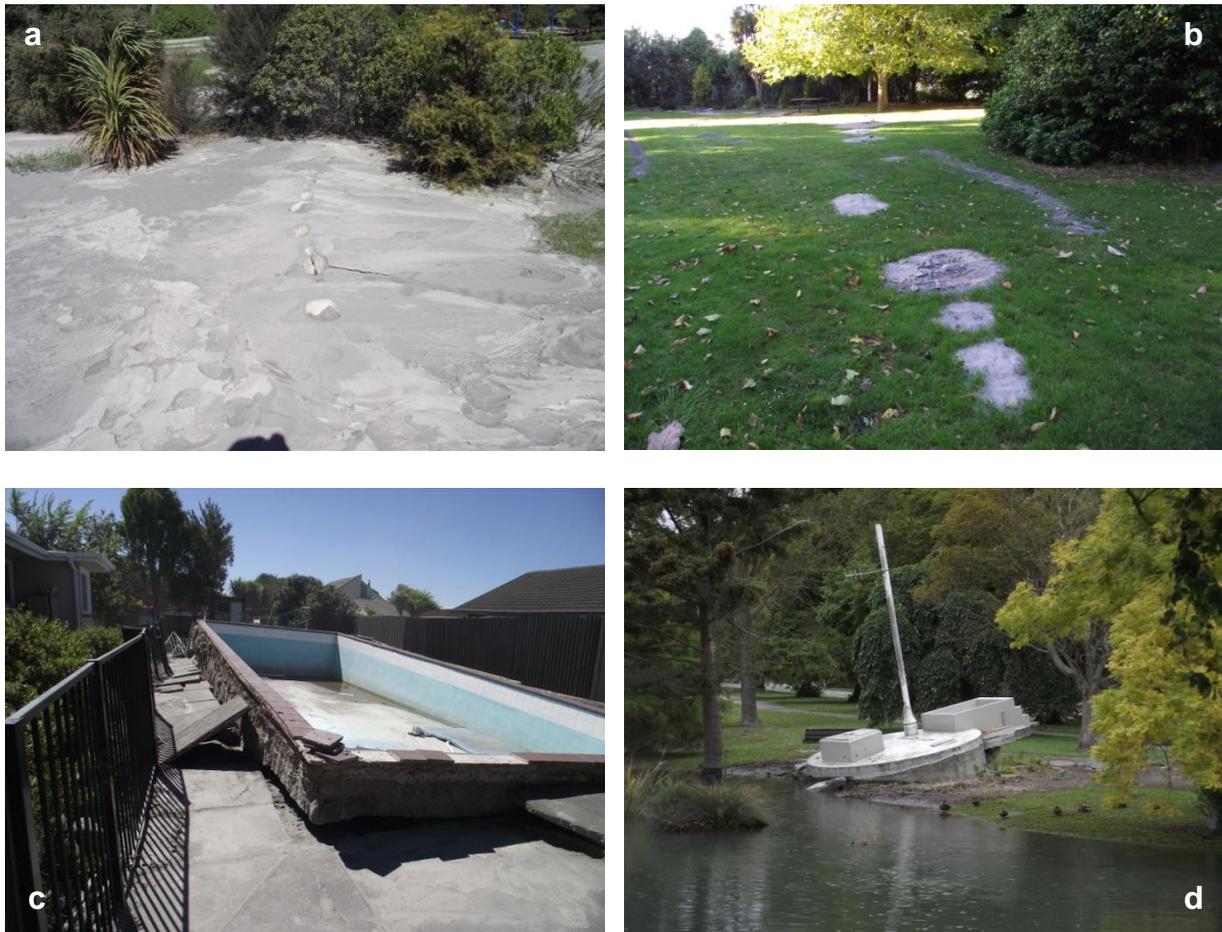
Figure 1 Photos from Christchurch showing evidence of liquefaction in the form of sand boils along “fissures”. a) The Avon River right bank at Anzac Bridge. b) Mona Vale gardens in Fendalton. c) This swimming pool was full of water during the Darfield Earthquake and stayed in the ground when the site liquefied. However, it was empty and “floated” when the site liquefied in the Christchurch Earthquake. d) This pumping station caisson floated and moved laterally during both earthquakes.

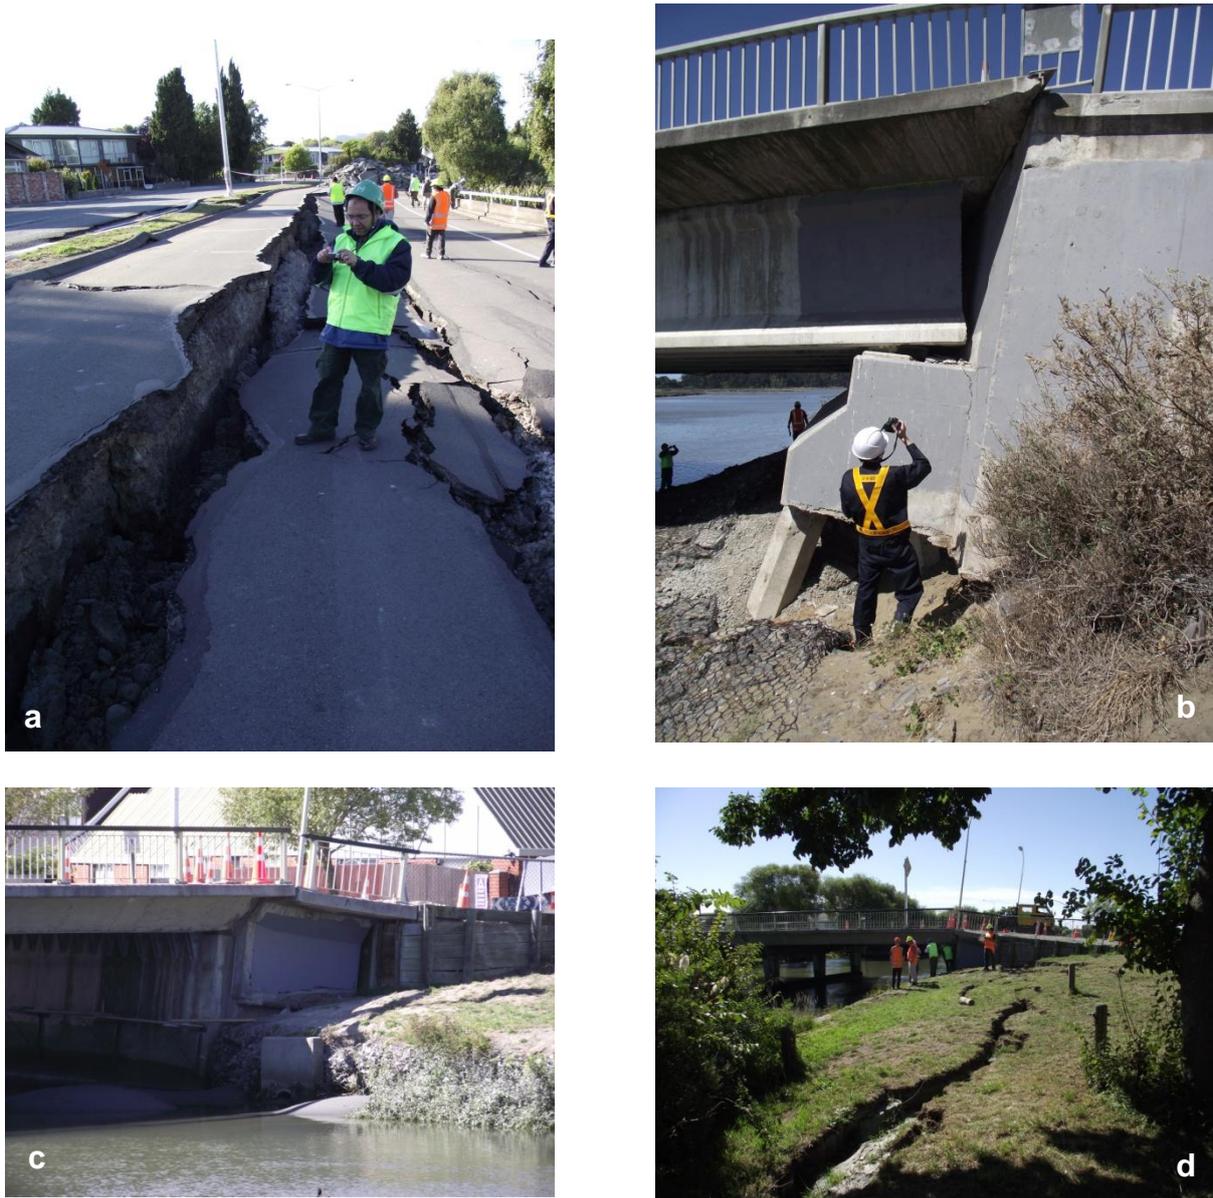
Figure 2 These photos provide examples of lateral spreading and settlement adjacent to the Avon River after the Christchurch Earthquake: a) Fitzherbert Terrace near the junction with Avonside Drive; b) Bridge St. bridge near New Brighton showing abutment settlement and rotation; c) the Avondale Rd. bridge with lateral spreading cracks and d) abutment rotation and settlement.

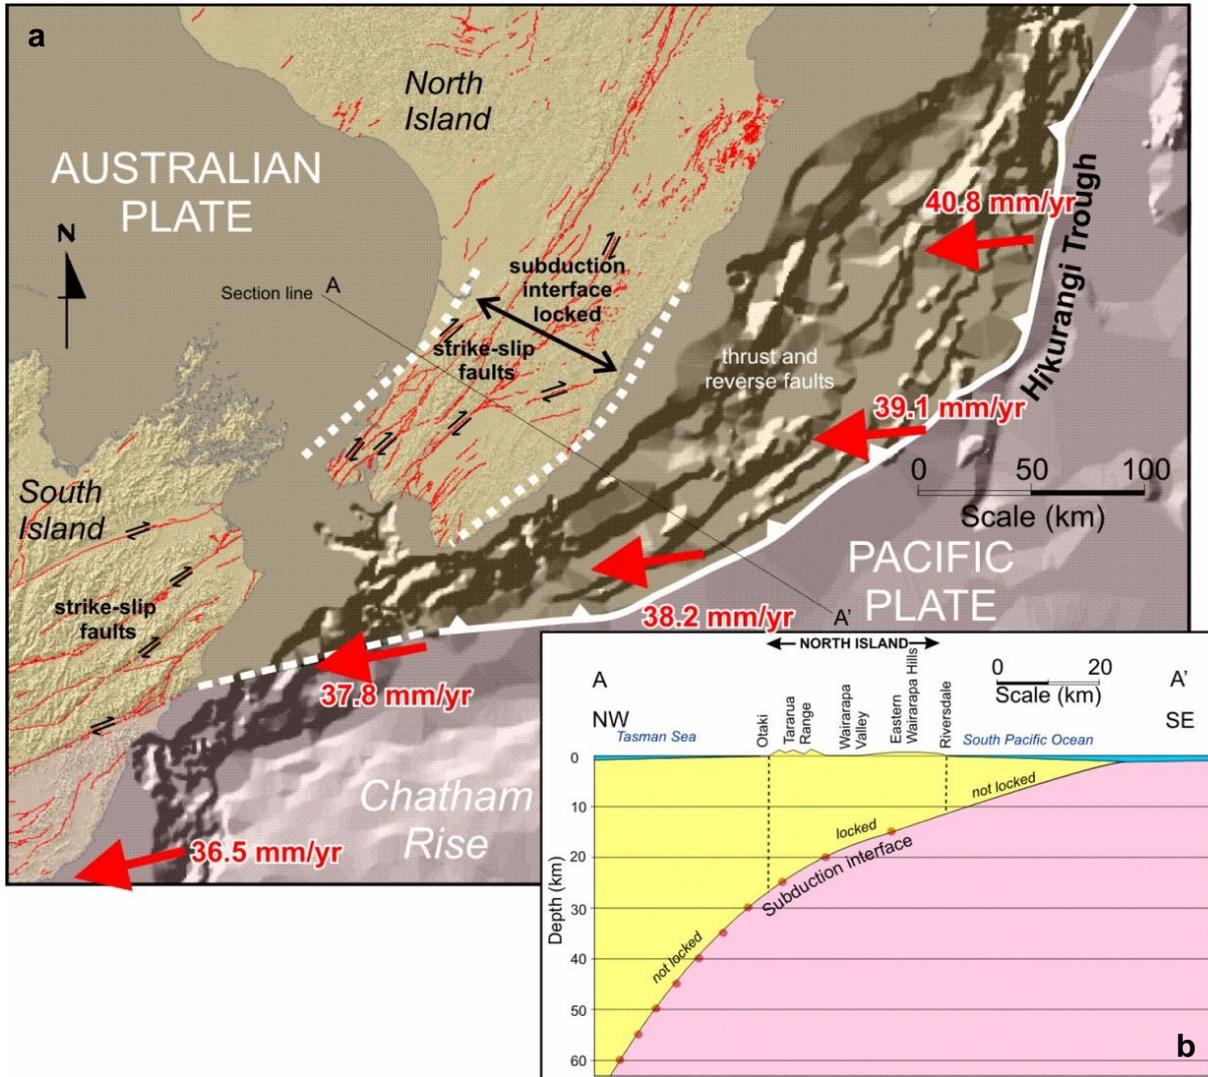
Figure 3 a) Palmerston North City lies close to the boundary between the Pacific (here coloured pink) and Australian (yellow) tectonic plates. The plates are moving across the surface of the globe at differing rates and the relative difference is represented here by convergence rates at specific places along the boundary (red arrows and numbers). b) The Manawatu region sits behind the outer edge of the Australian Plate at the western margin of a zone where the west-dipping plate interface is locked. Locking of the plate interface, and the relative convergence rates and vectors contribute to the upward bulge in the Australian Plate that is the landmass of the southern North Island. The offshore DEM is derived from bathymetric contours.

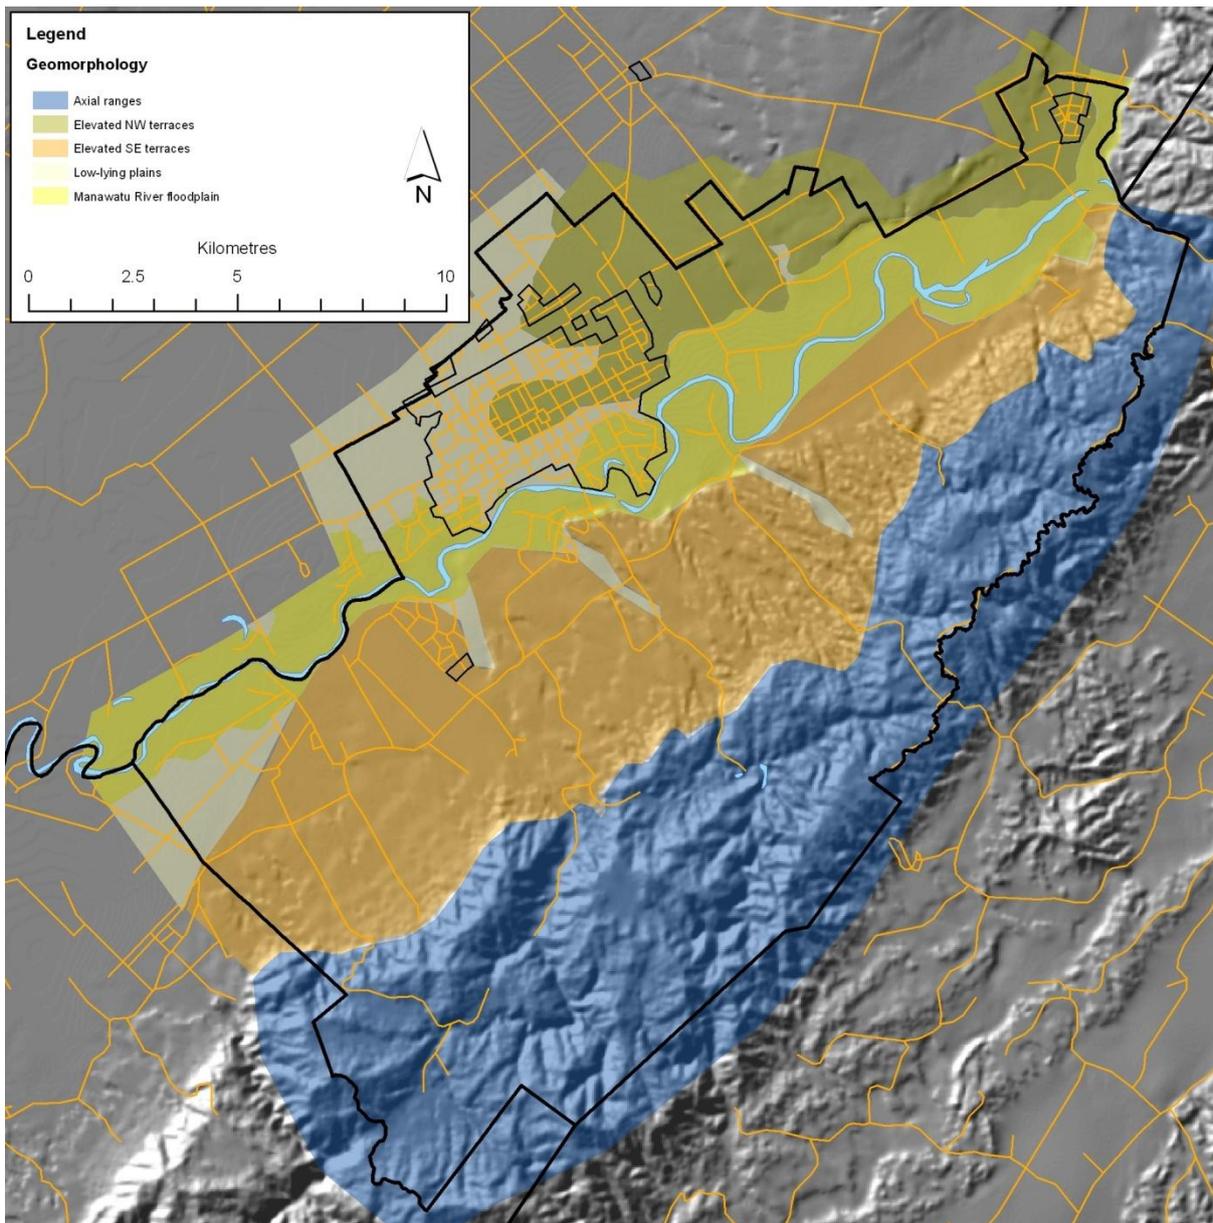
Figure 4 Generalised geomorphology of Palmerston North City. The authority boundary is shown as a heavy black line, and the built-up urban areas are also outlined in black. Further discussion of the physiography can be found in Appendices 3 and 4.

This appendix provides a geomorphic context for the brief notes made within the text, and the spatial distribution of the units discussed are illustrated in Figure 4.

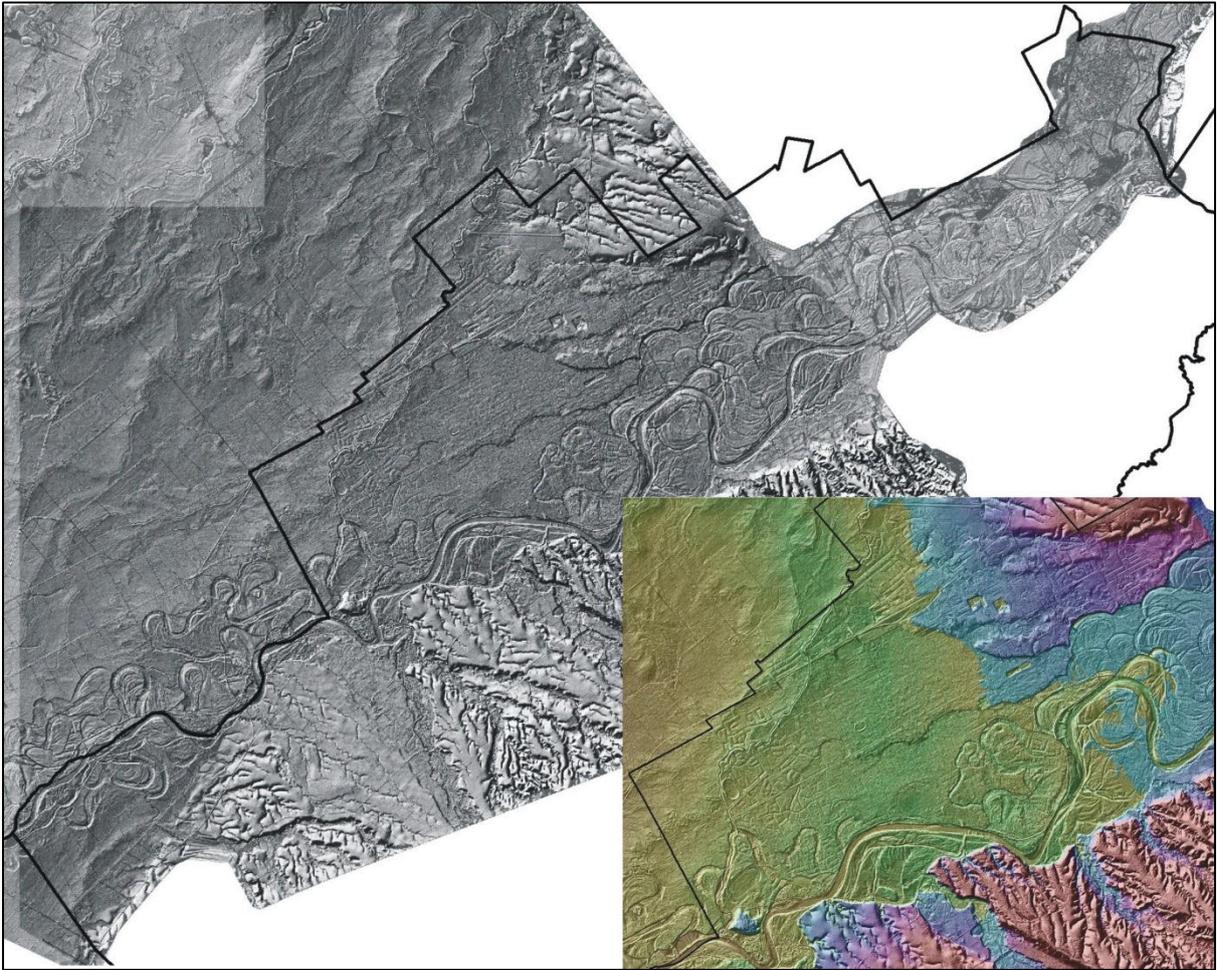
Figure 5 A hillshade derived from Lidar Digital Elevation Models (DEMs) of the Palmerston North City area. The heavy black line marks the Palmerston North City boundary. A smaller area of the City itself is imaged in the inset; here the hillshade is underlain by a colour-ramped DEM, where colour bands depict areas of similar elevation.

- Delineation of river channels and floodplains (Figure 5);
- Refinement of existing geology and soil map boundaries;

The lidar DEM provides a high resolution and accurate surface model on which to base other data and our Holocene geology interpretations (see Figure 5, also, Figures 14 & 15, Appendix 4). The DEM constrains and improves the accuracy of drillhole collar heights, and therefore downhole depths. It also provides accurate information that feeds into interpretation of the origin of materials underlying the surface.

4. Our map differs significantly from the 1994 GNS assessment. We consider that the area of the city with the highest liquefaction susceptibility is the recent flood plain of the Manawatu River (Figure 8b) with its old infilled channels which show up beautifully on the lidar maps (Figures 5, 8c & 10). This flood plain has a variable thickness of loose, fine sand and silt flood deposits which range in thickness from zero to 6 m or more. However, this material is not always saturated as permeable gravels underly the fine sands. For this reason the liquefaction susceptibility is rated from 1 (very high) to 3 (moderate), although areas of gravel would have low to nil liquefaction susceptibility. Where there is sloping ground combined with saturated highly susceptible soils, lateral spreading could occur in this zone.

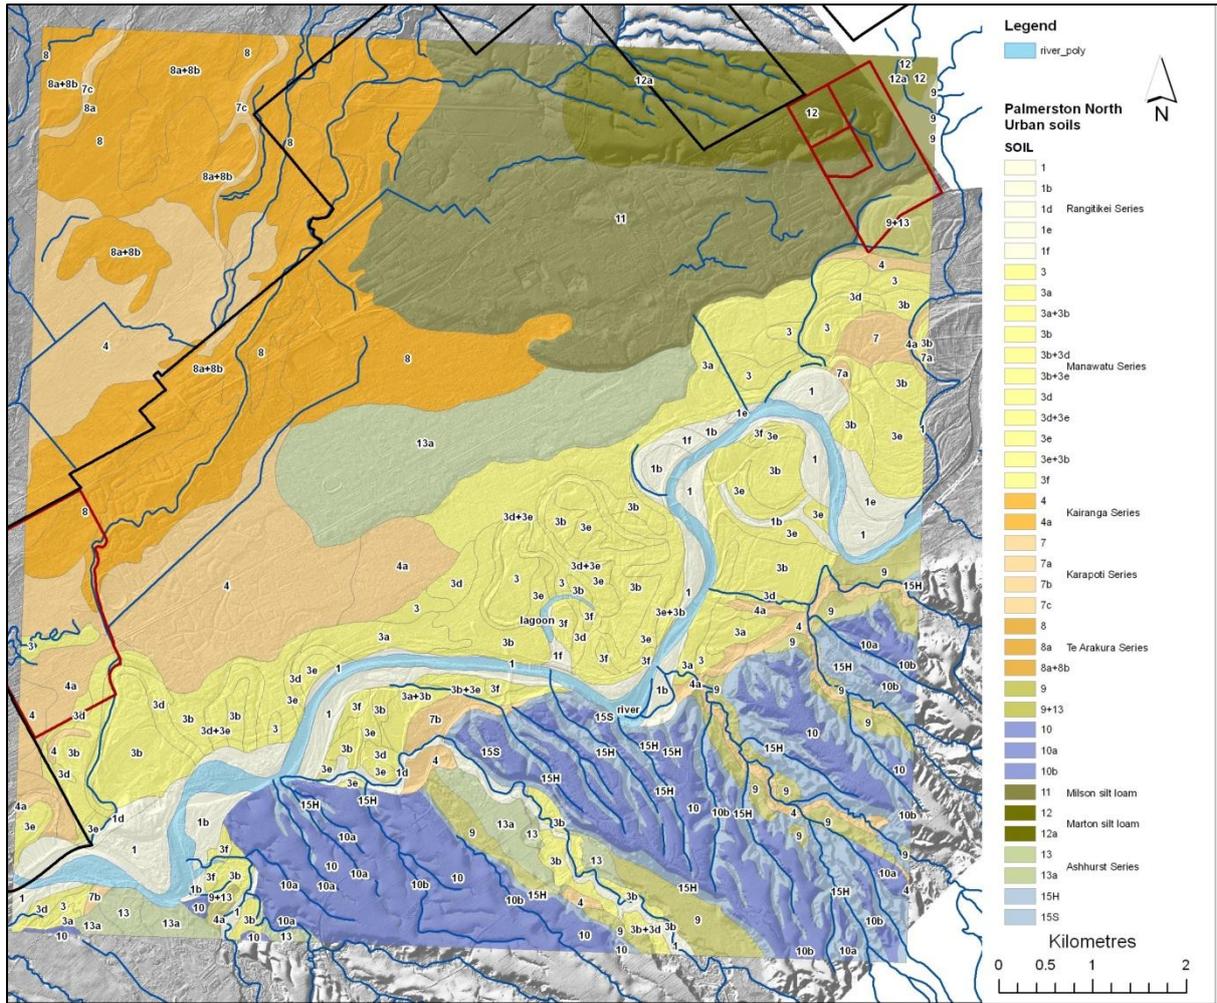
Figure 6 The soils of Palmerston North (after Cowie 1974) are subdivided into two, soils of the river flats (yellow and orange), and those of the terraced land (blue and green). Soils on the terraced land are usually thicker and more structured than those on the river flats.

Palmerston North, as depicted in Fig. 6 and Appendix 5, is founded on a variety of soil types. High quality soil maps cover some parts of Palmerston North City (Cowie, 1974; Cowie & Kimpton, 1976; Cowie, 1979; Figure 6). These soil types have characteristics that contribute to understanding liquefaction potential. Grading curves of soils within the PNCC area have been obtained from Soil Bureau archives and typical curves are presented in Appendix 6.

The remaining soils in the PNCC area have negligible liquefaction potential. The location of all the soils in the PNCC area are clearly shown on Figure 6.

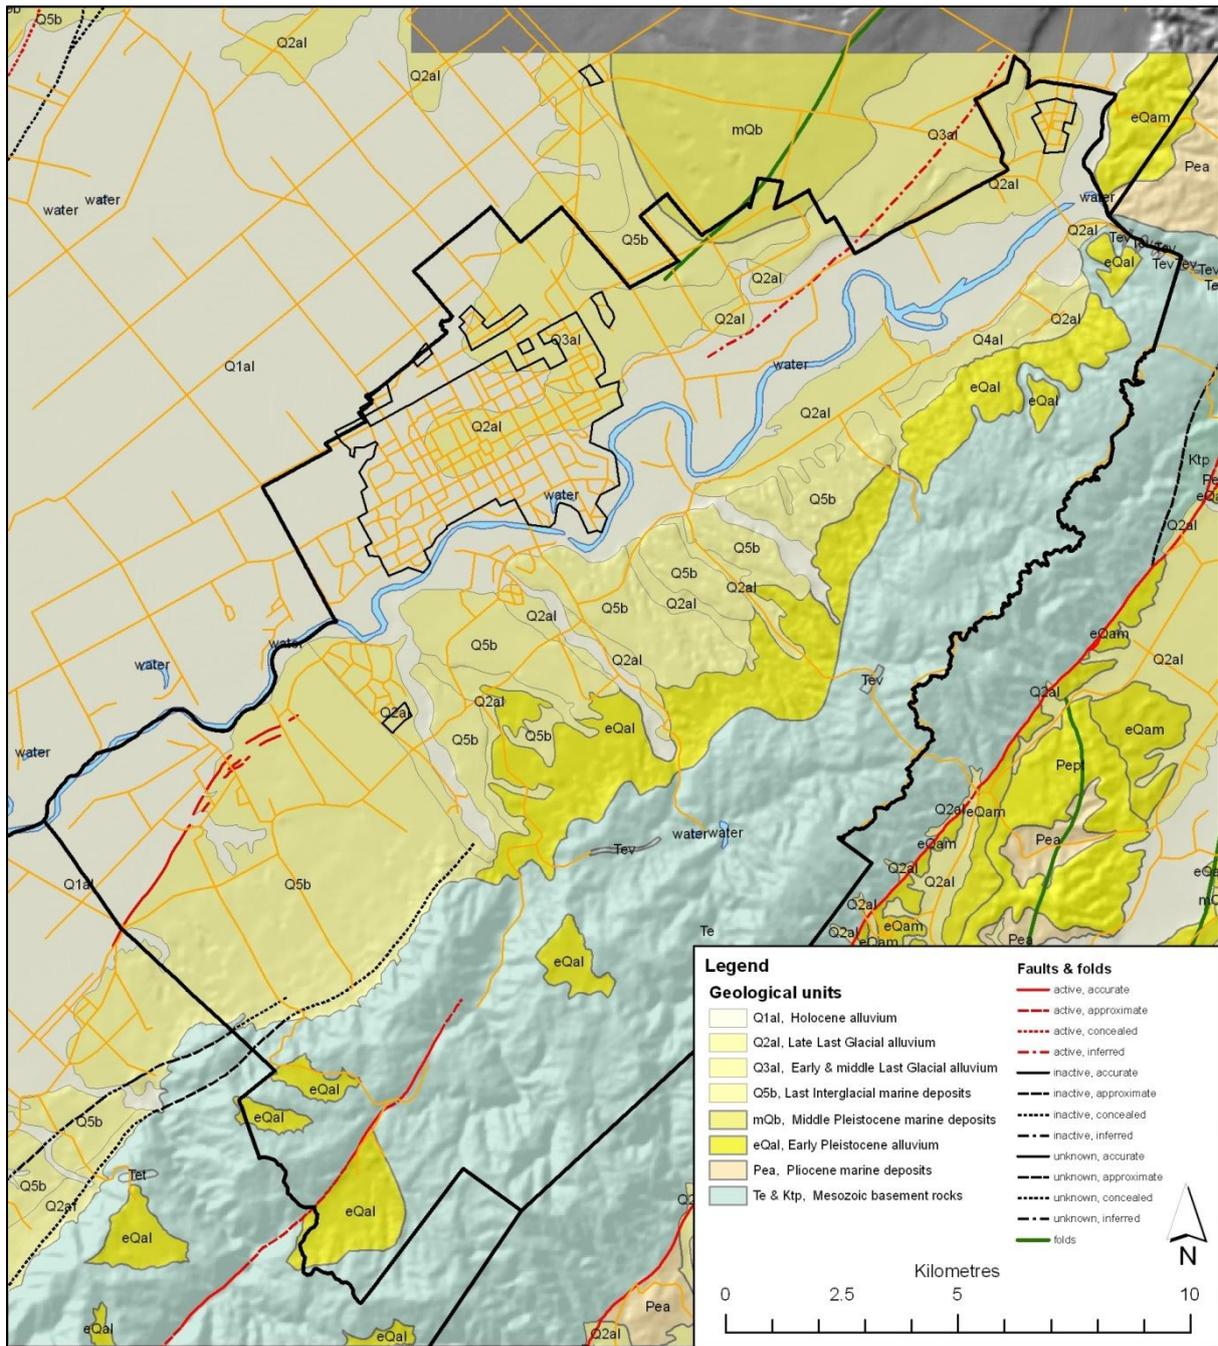
Figure 7 A simplified geological map of the Palmerston North City area.

This appendix supplements the brief comments on soil types made in the main body of the text. A soil map of the Palmerston North City area is included in the illustrations to the main text (Figure 7).

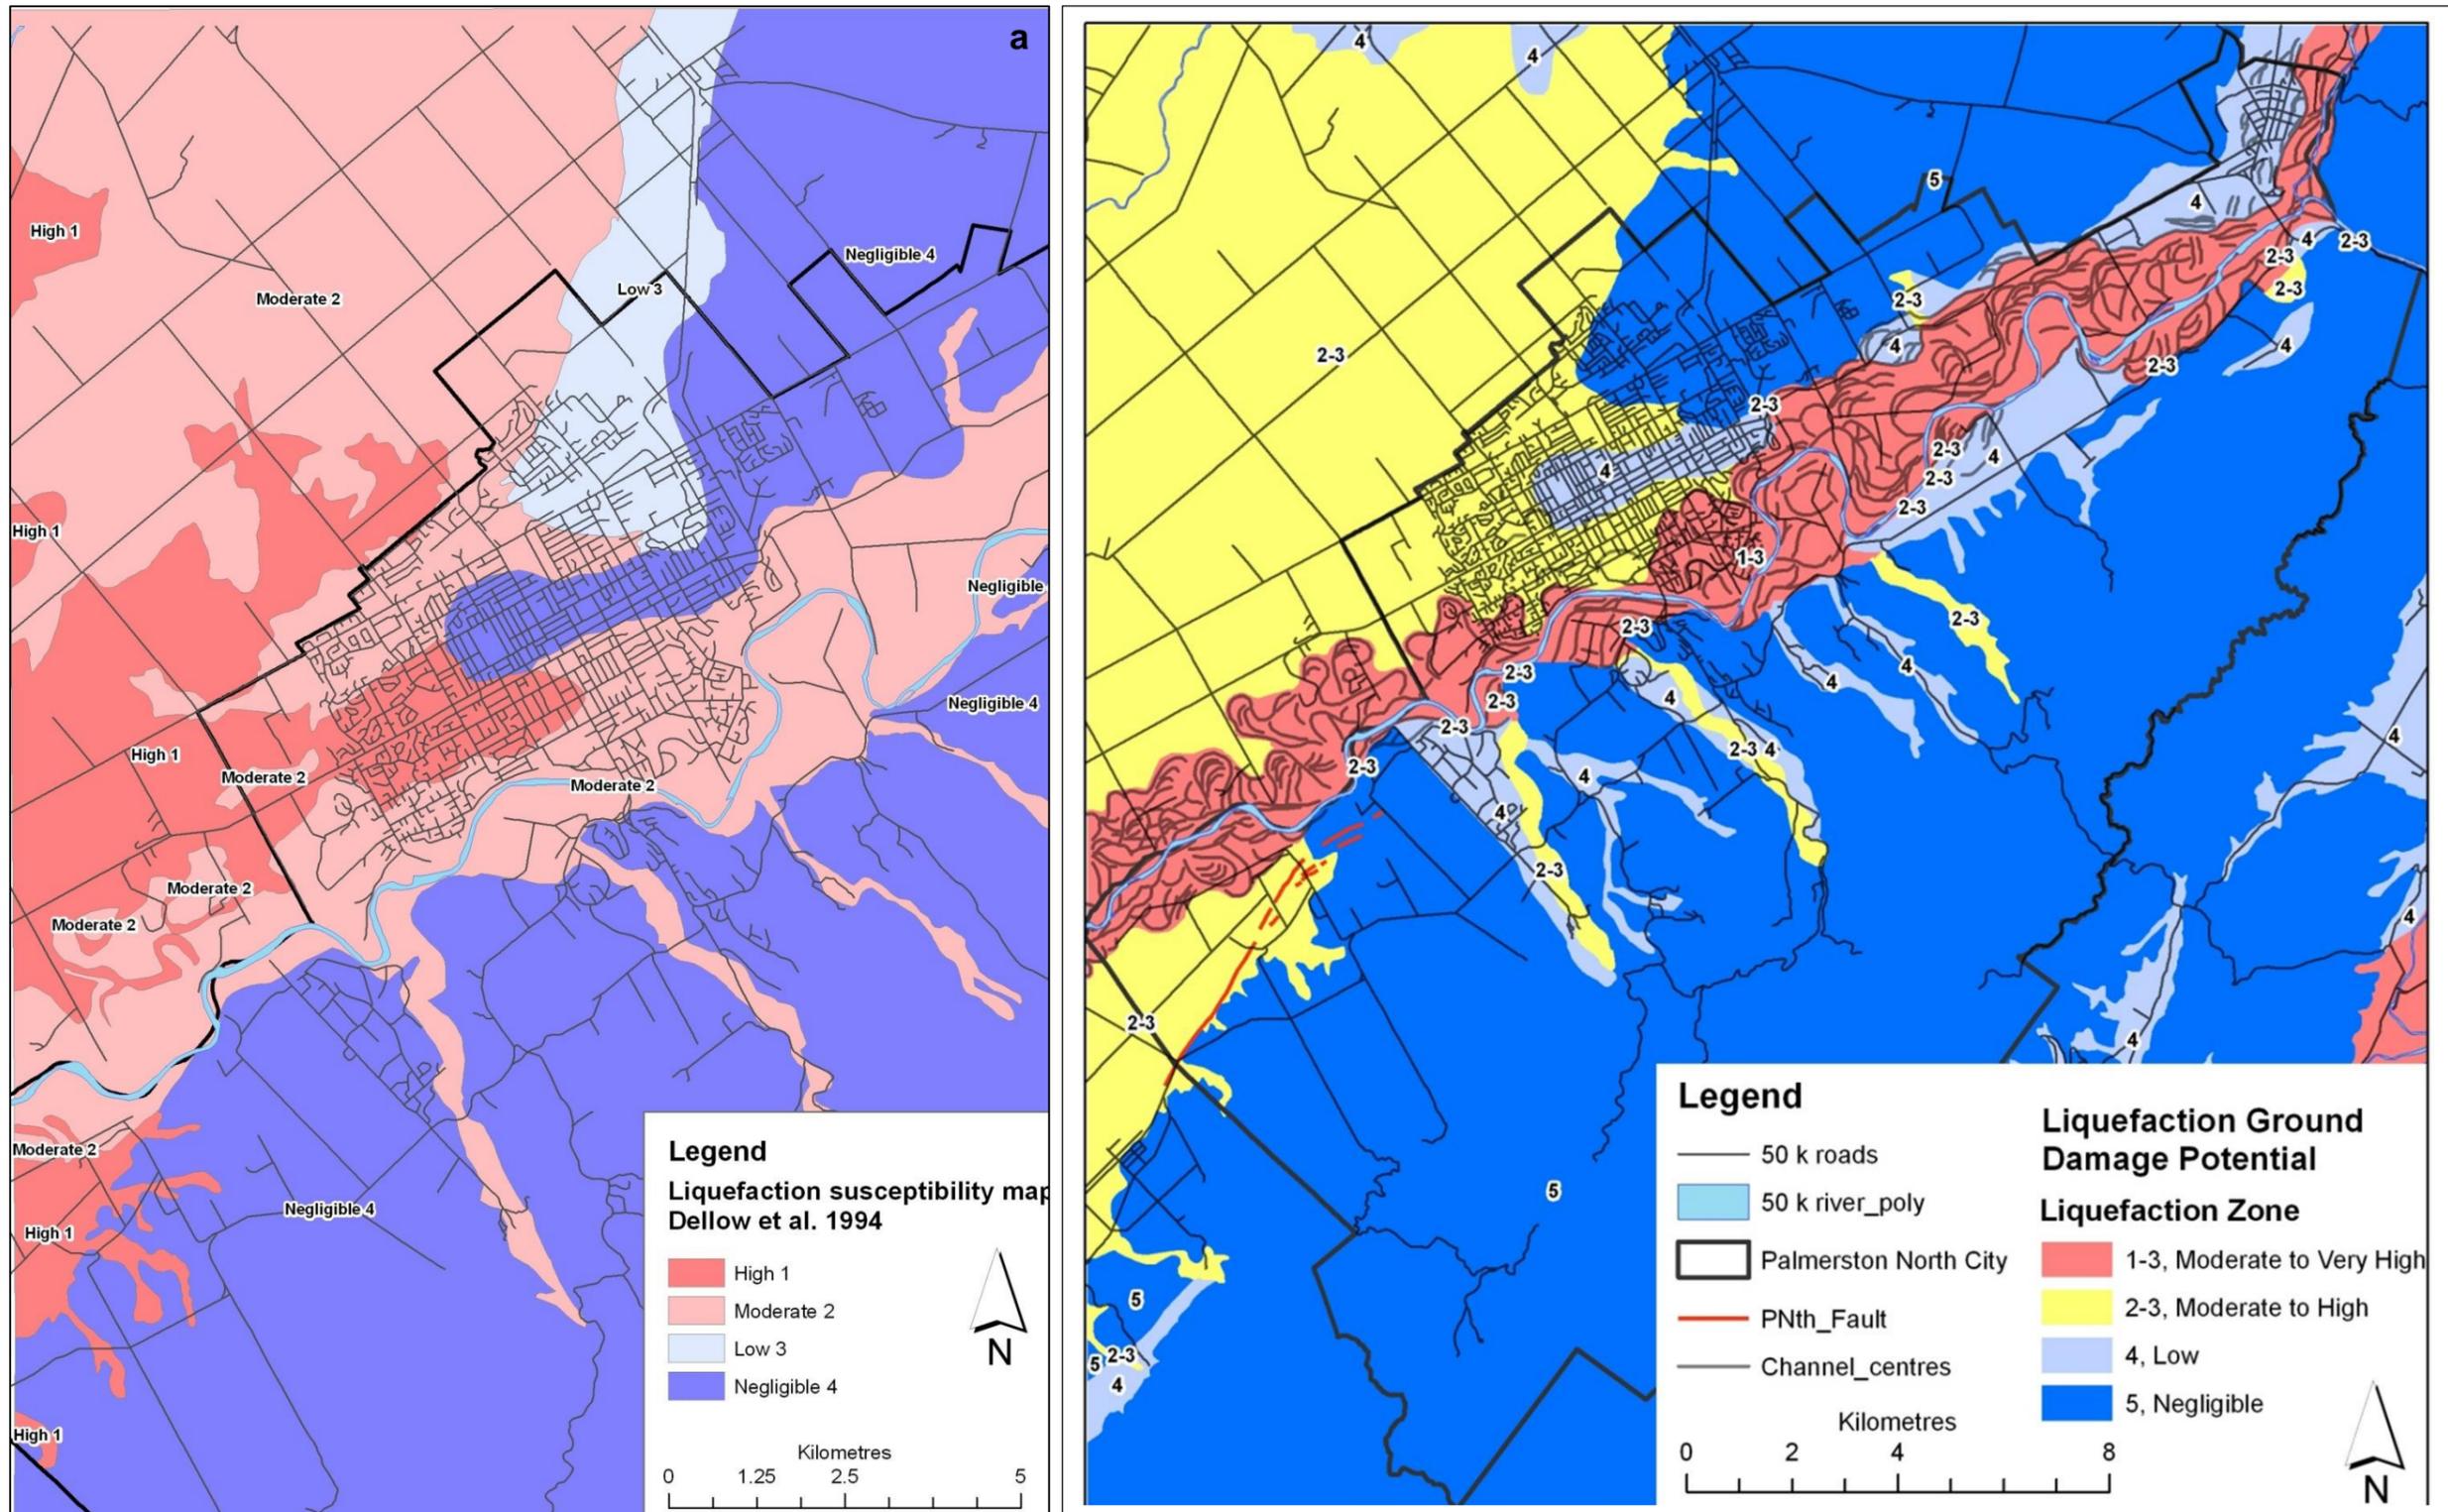
Figure 8 a) Comparison between a) the liquefaction susceptibility map of Dellow et al. (1994), and b) a liquefaction susceptibility map generated using the same methodology, but independently, for this job using higher quality physiographic and more recent geological information. In both figures, dark blue represents areas where there is negligible liquefaction susceptibility; light blue, low liquefaction susceptibility. In the left map, pink represents areas of moderate, and red, high liquefaction susceptibility. In the right hand map, pink represents areas zoned 2-3 (possible to moderate liquefaction susceptibility and red, areas zoned 1-3 (possible to high liquefaction susceptibility). In the new map, river channel centres and relict river channel centres are added as black lines, mostly across the late Holocene floodplain of the Manawatu River.

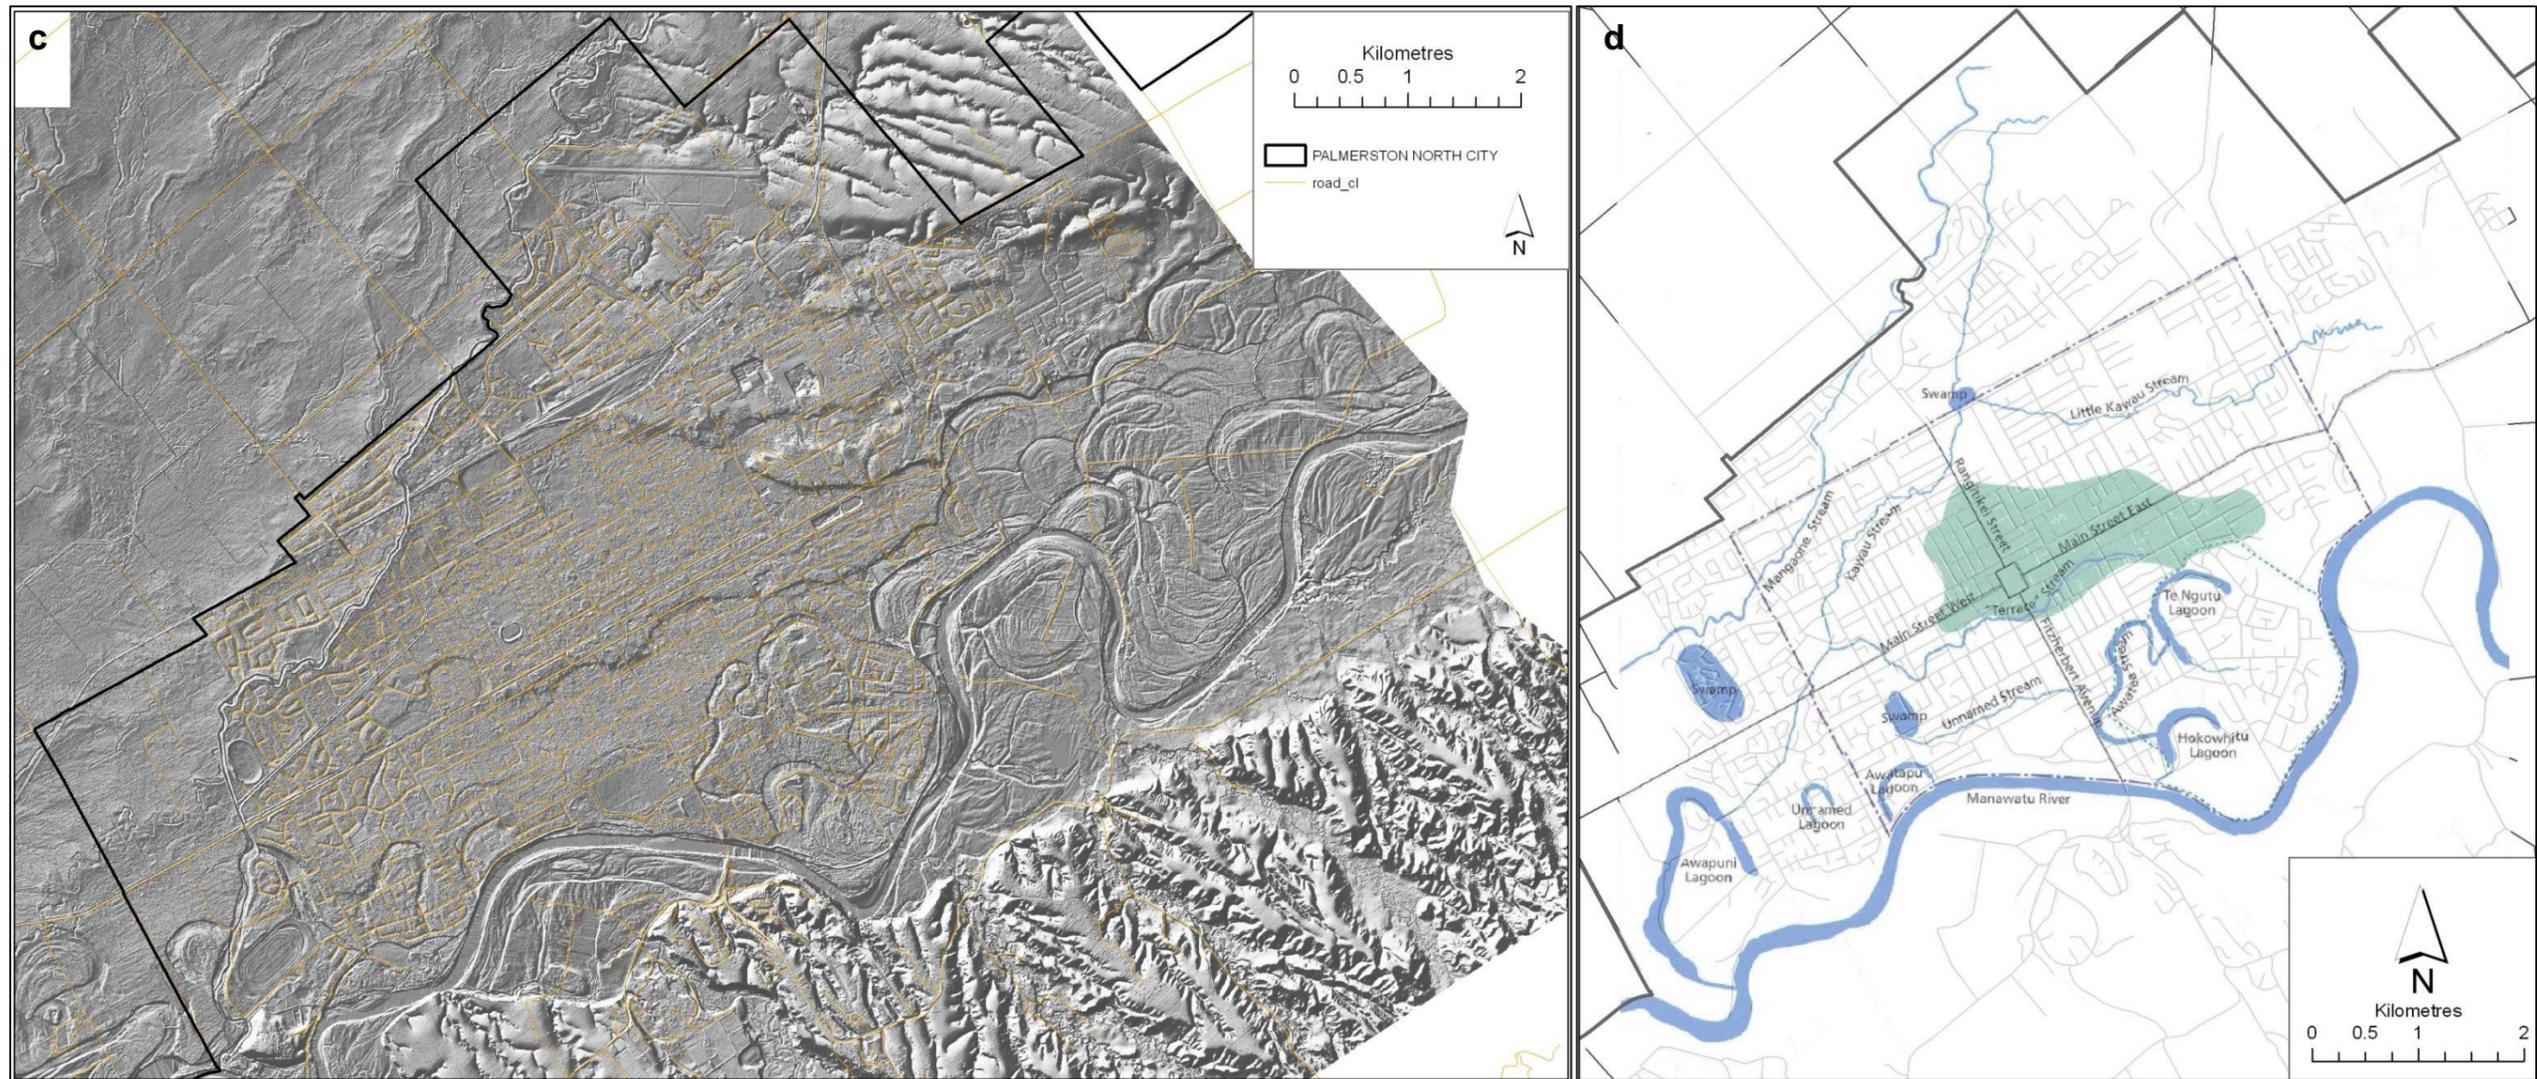
Figure 8 c) The Lidar DEM with shading (top) compared at the same scale to an early map of Palmerston North showing the city area as it was in 1896. Areas of old stream and river channels, old lagoons and swamps seen on both images may contain weak sediments, including peats, that are susceptible to settlement and earthquake induced liquefaction and lateral spreading effects. Special care is needed with site investigations and foundation design in these areas; d) Matheson (2003) compiled a map from early surveyors records of the location of swamps and lakes in Palmerston North City area. The green area represents the original clearing that Palmerston North was built on.

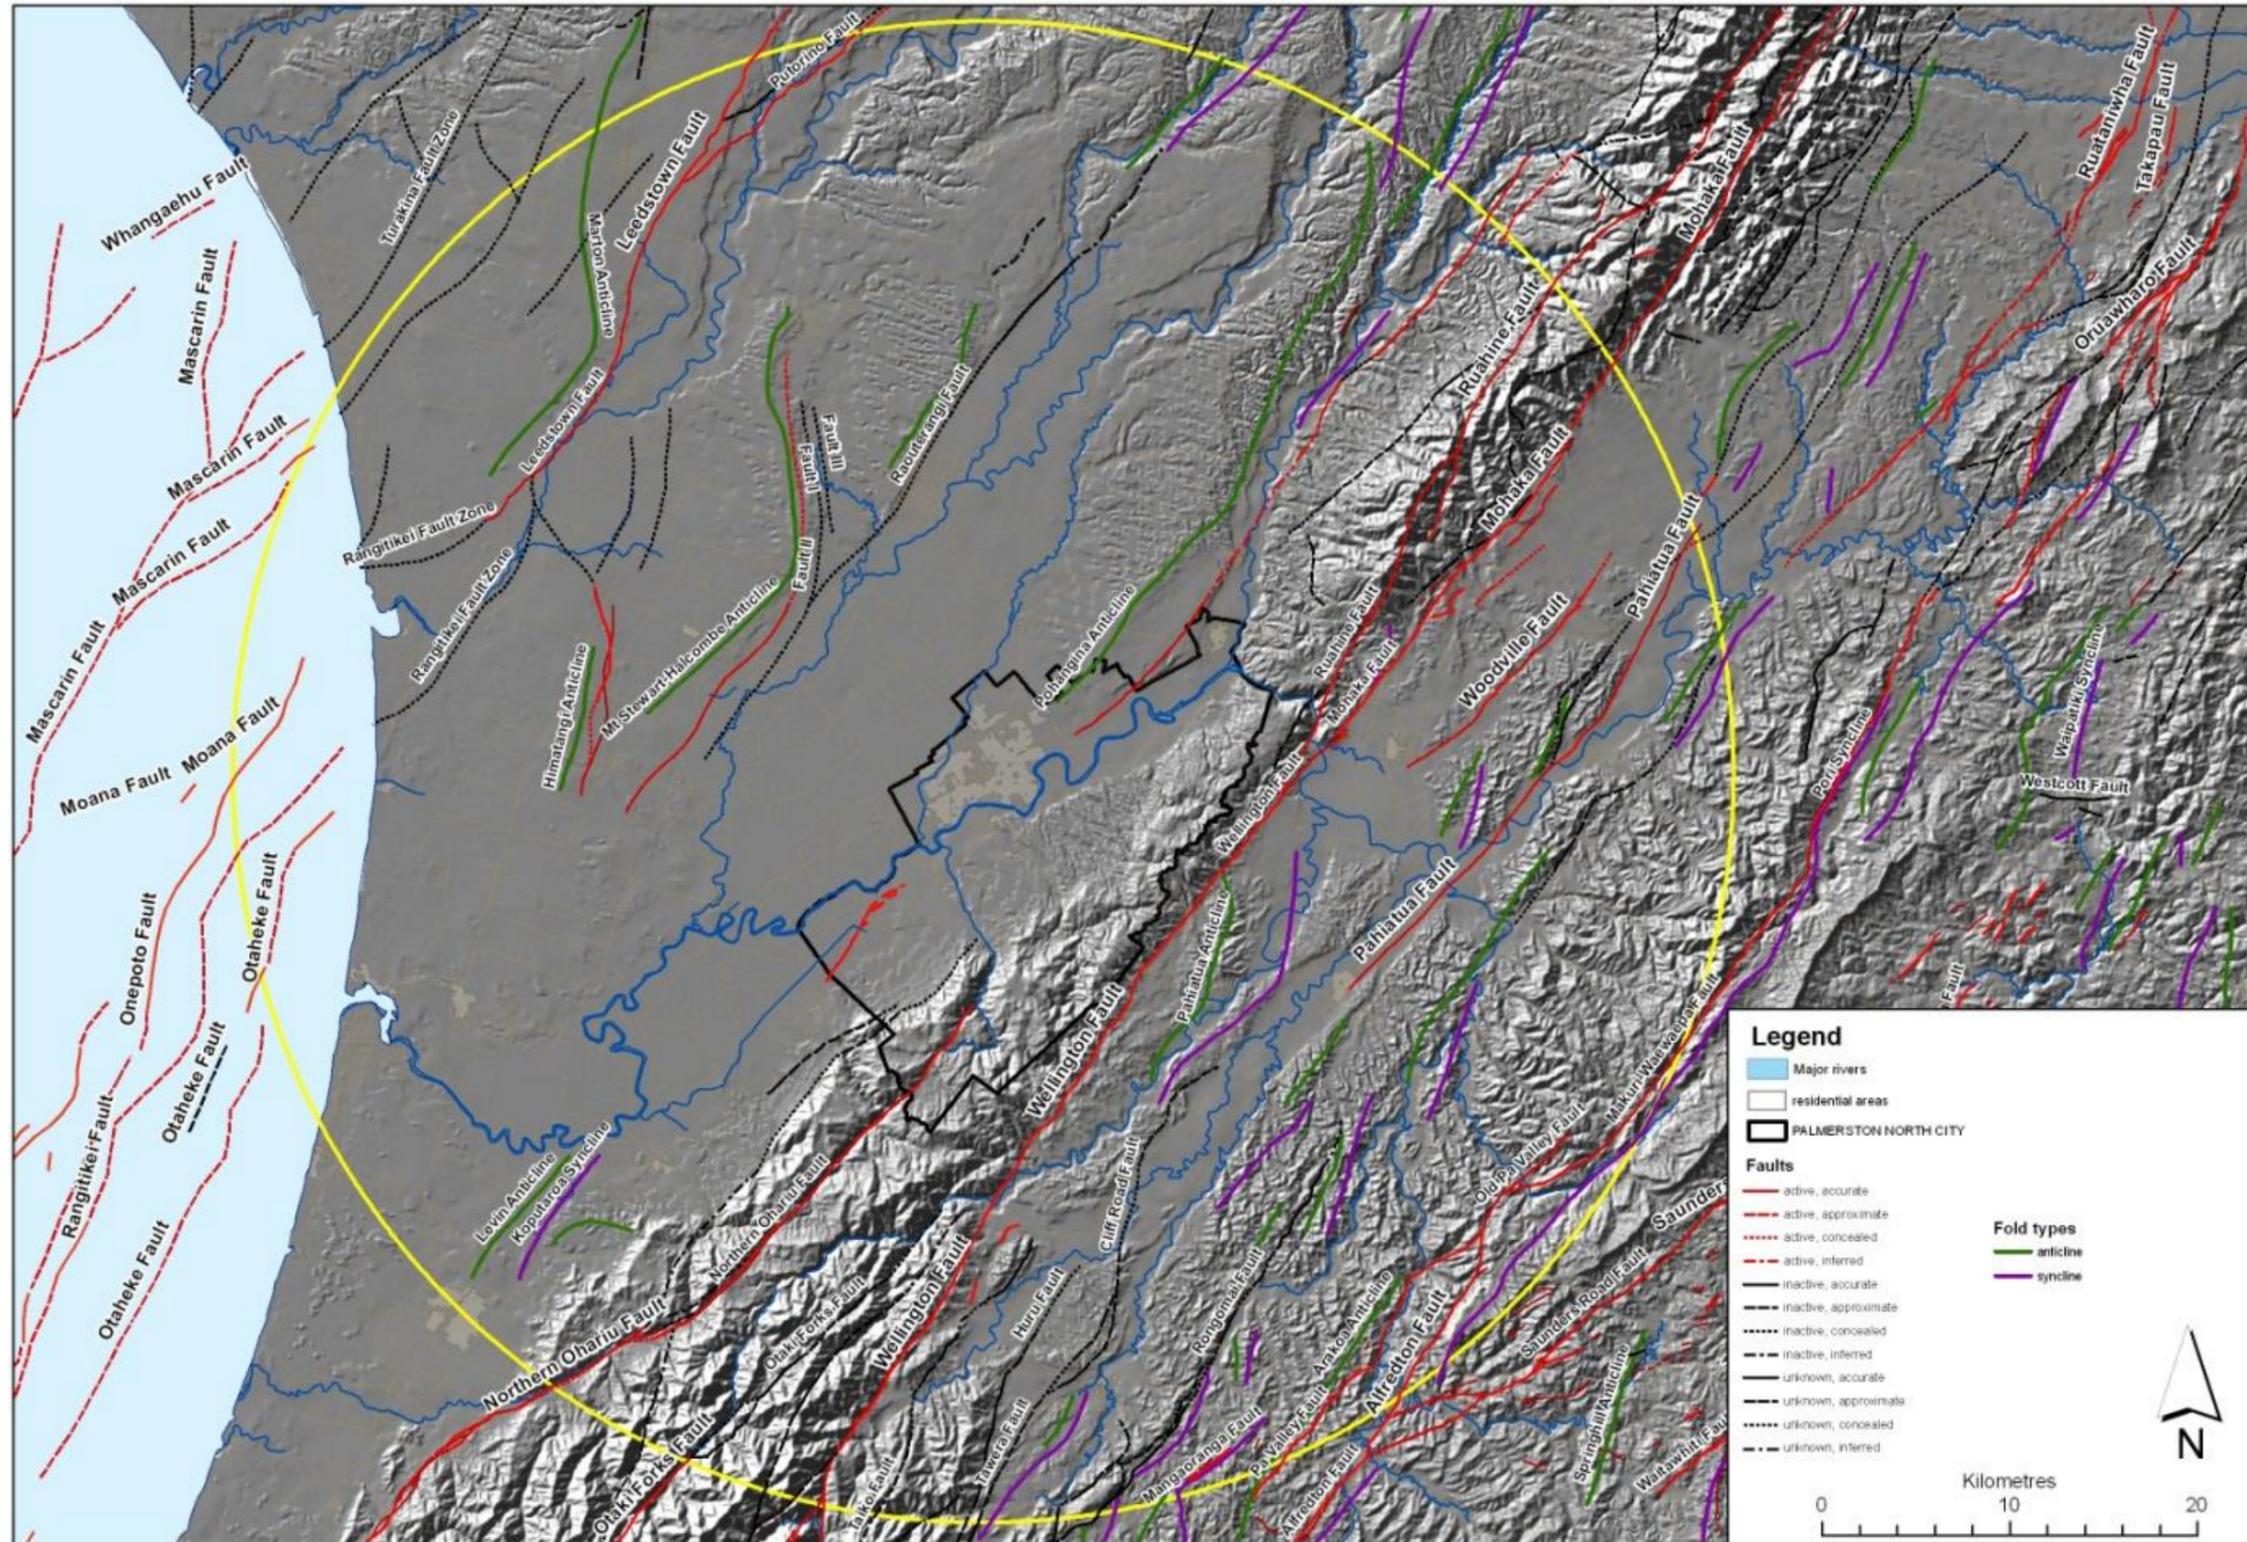
Figure 9 Surface and immediately subsurface seismicogenic faults and folds of the Palmerston North area. The yellow circle has a radius of 40 km from Palmerston North City Centre. The most significant source is the Wellington-Mohaka Fault which lies within 15 km of the City Centre. Other important faults include the subduction interface, c. 25 km beneath the city, the Ruahine and Northern Ohariu faults, and a newly discovered feature (arrowed), probably an active fault in the southwest of the City area. Anticlinal folds are commonly associated with underlying active reverse faults west of the Wellington Fault.
