**Assessment of liquefaction and related ground  
failure hazards in Palmerston North, New Zealand**

**GNS Science Consultancy Report 2011/108  
July 2011**

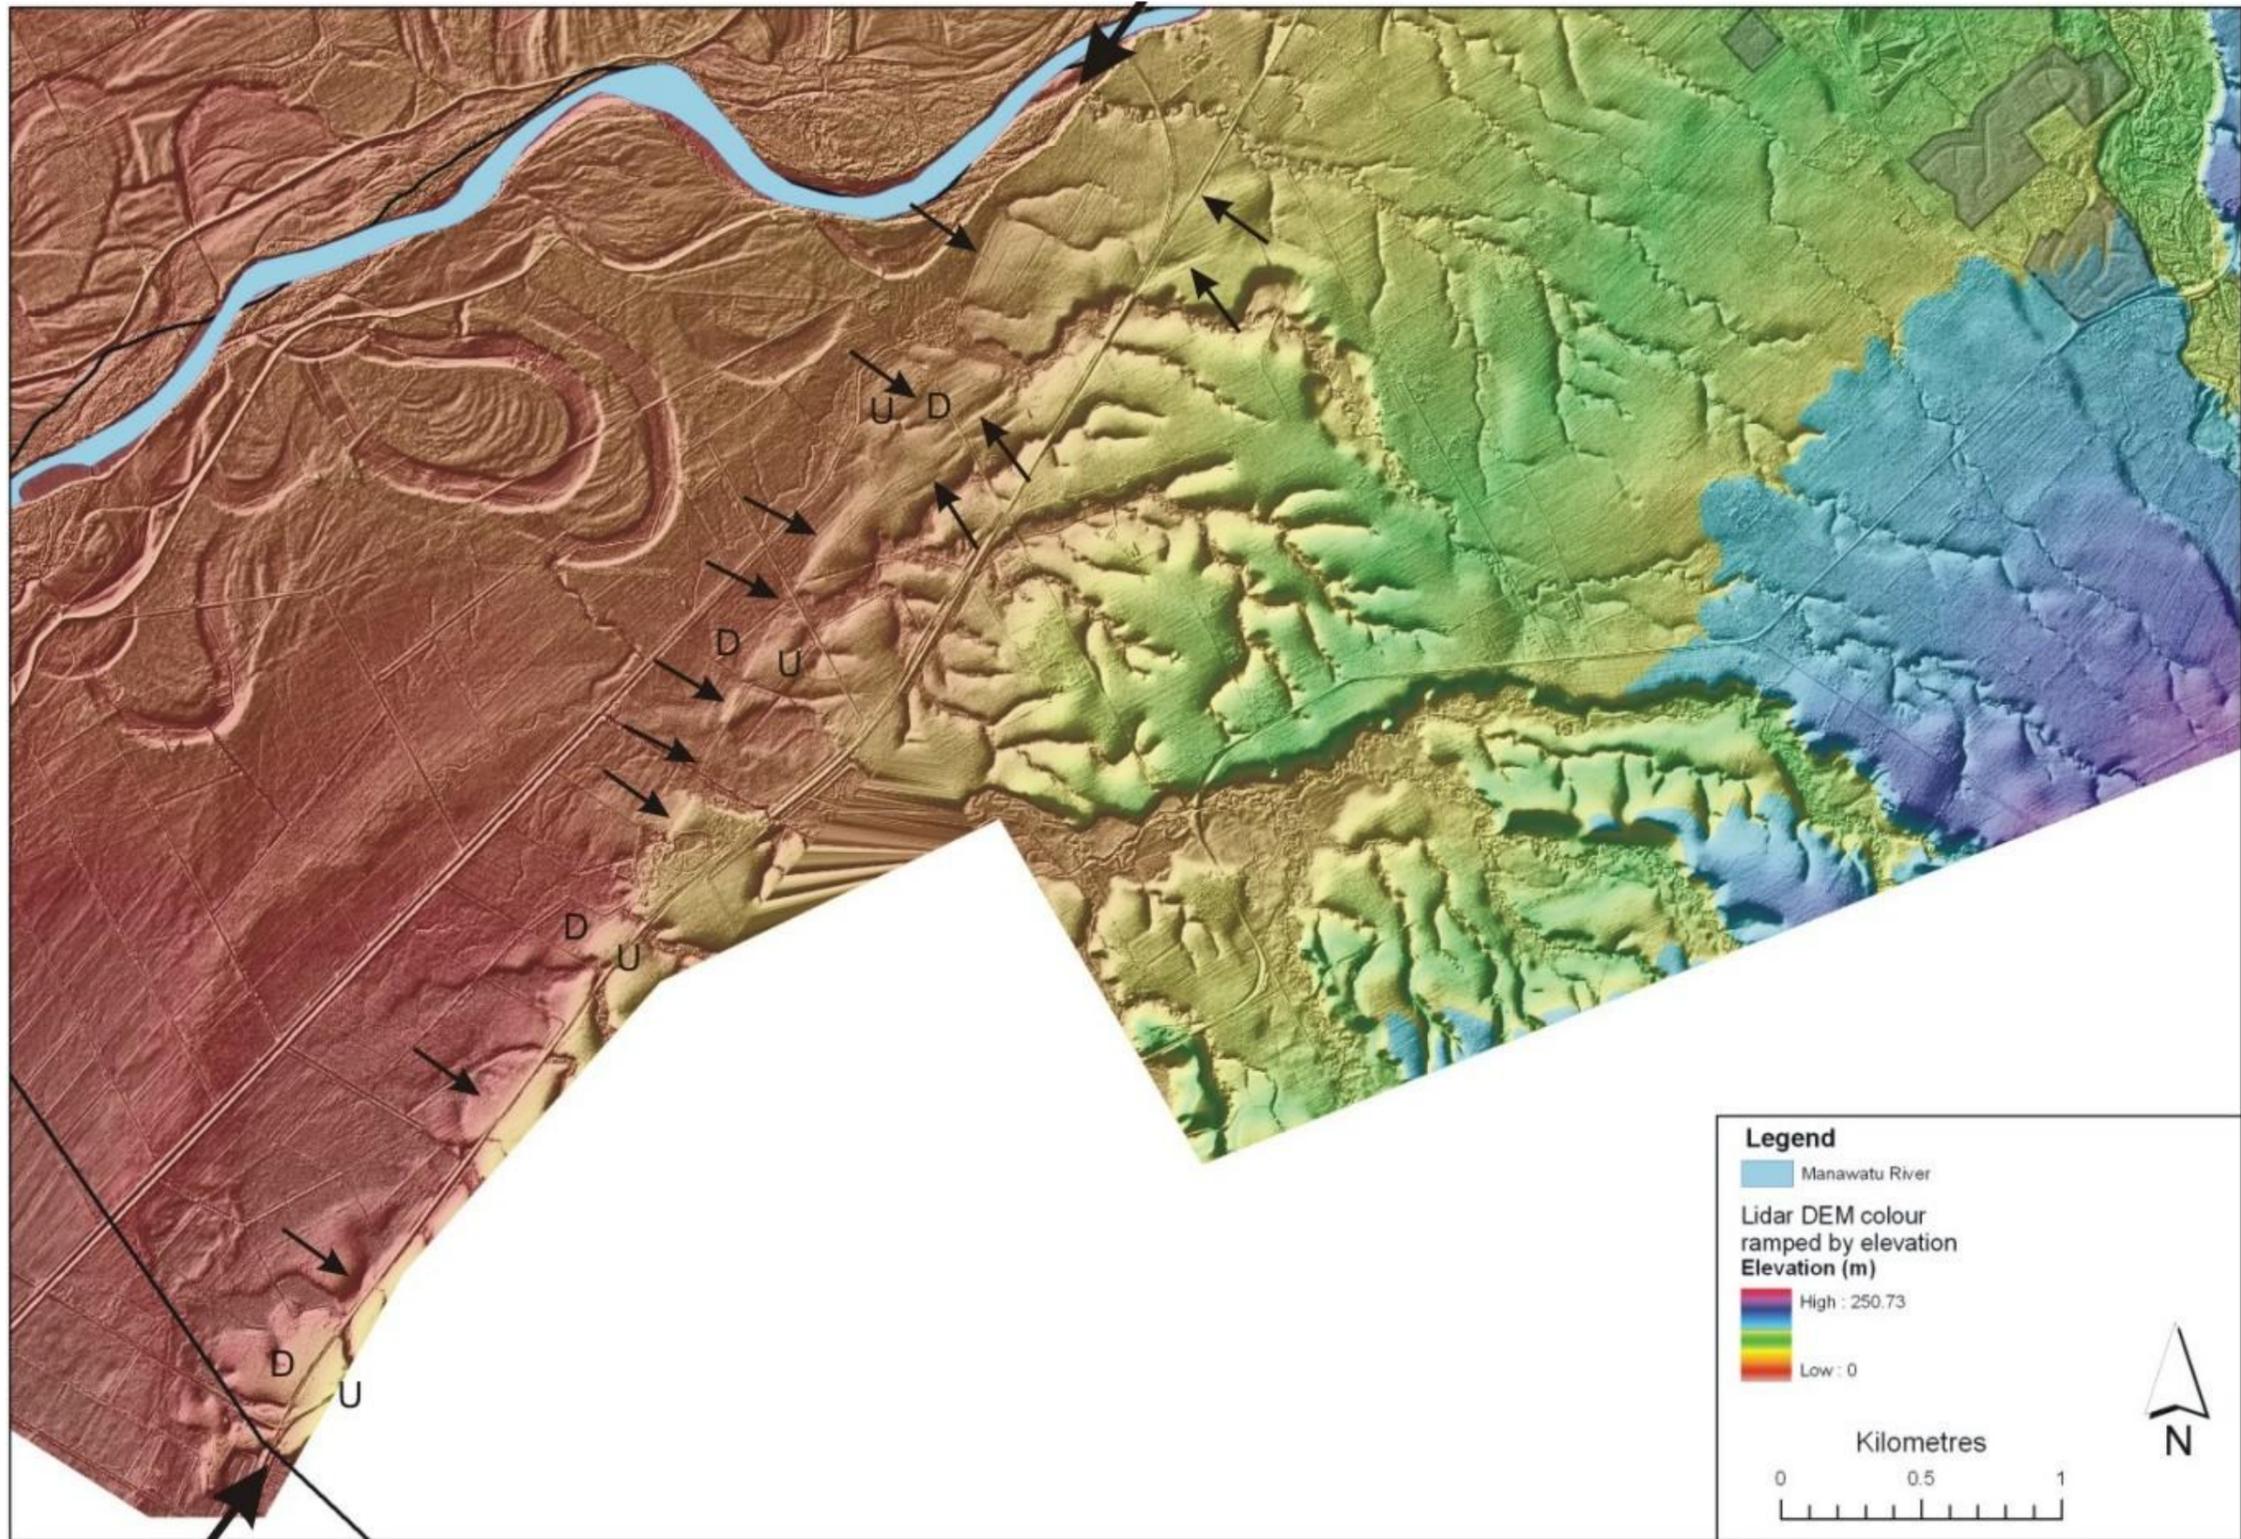
Figure 10 A geomorphic feature in the extreme SW of the Palmerston North City area shows many of the hallmarks of an active fault, as illustrated in this high resolution lidar DEM and hillshade. The sharp, linear feature (arrowed) is consistently elevated on the SE side and appears to displace Holocene fan deposits. Close to the NE end of the preserved lineament, it splays eastwards in a number of traces, and a small graben has developed, with the northwestern bounding feature downthrown to the SE. If the feature is a fault, it strikes towards Palmerston North City, its northeastern visible extent becoming obscured by active alluvial processes of the Manawatu River floodplain. In this map, Linton is marked on the northeastern edge as a grey shaded area. U = upthrown side, D = downthrown side.

4. Our map differs significantly from the 1994 GNS assessment. We consider that the area of the city with the highest liquefaction susceptibility is the recent flood plain of the Manawatu River (Figure 8b) with its old infilled channels which show up beautifully on the lidar maps (Figures 5, 8c & 10). This flood plain has a variable thickness of loose, fine sand and silt flood deposits which range in thickness from zero to 6 m or more. However, this material is not always saturated as permeable gravels underly the fine sands. For this reason the liquefaction susceptibility is rated from 1 (very high) to 3 (moderate), although areas of gravel would have low to nil liquefaction susceptibility. Where there is sloping ground combined with saturated highly susceptible soils, lateral spreading could occur in this zone.

A sharp landscape lineament, c. 7 km long and striking c. 035°, is revealed by the lidar data in the extreme southwest corner of Palmerston North City (see Figure 10). The feature apparently extends southwest of the limits of lidar coverage and bears many characteristics of an active fault. The last interglacial surface is apparently downthrown to the west, and there is possibly a subtle displacement of the late Holocene surface material. The feature splays into several branches in its northern third, some with apparent downthrow to the NW, and some to the NE. A small graben feature is developed near its northeastern extent. In this report, it is listed in this report as a potential seismic source.

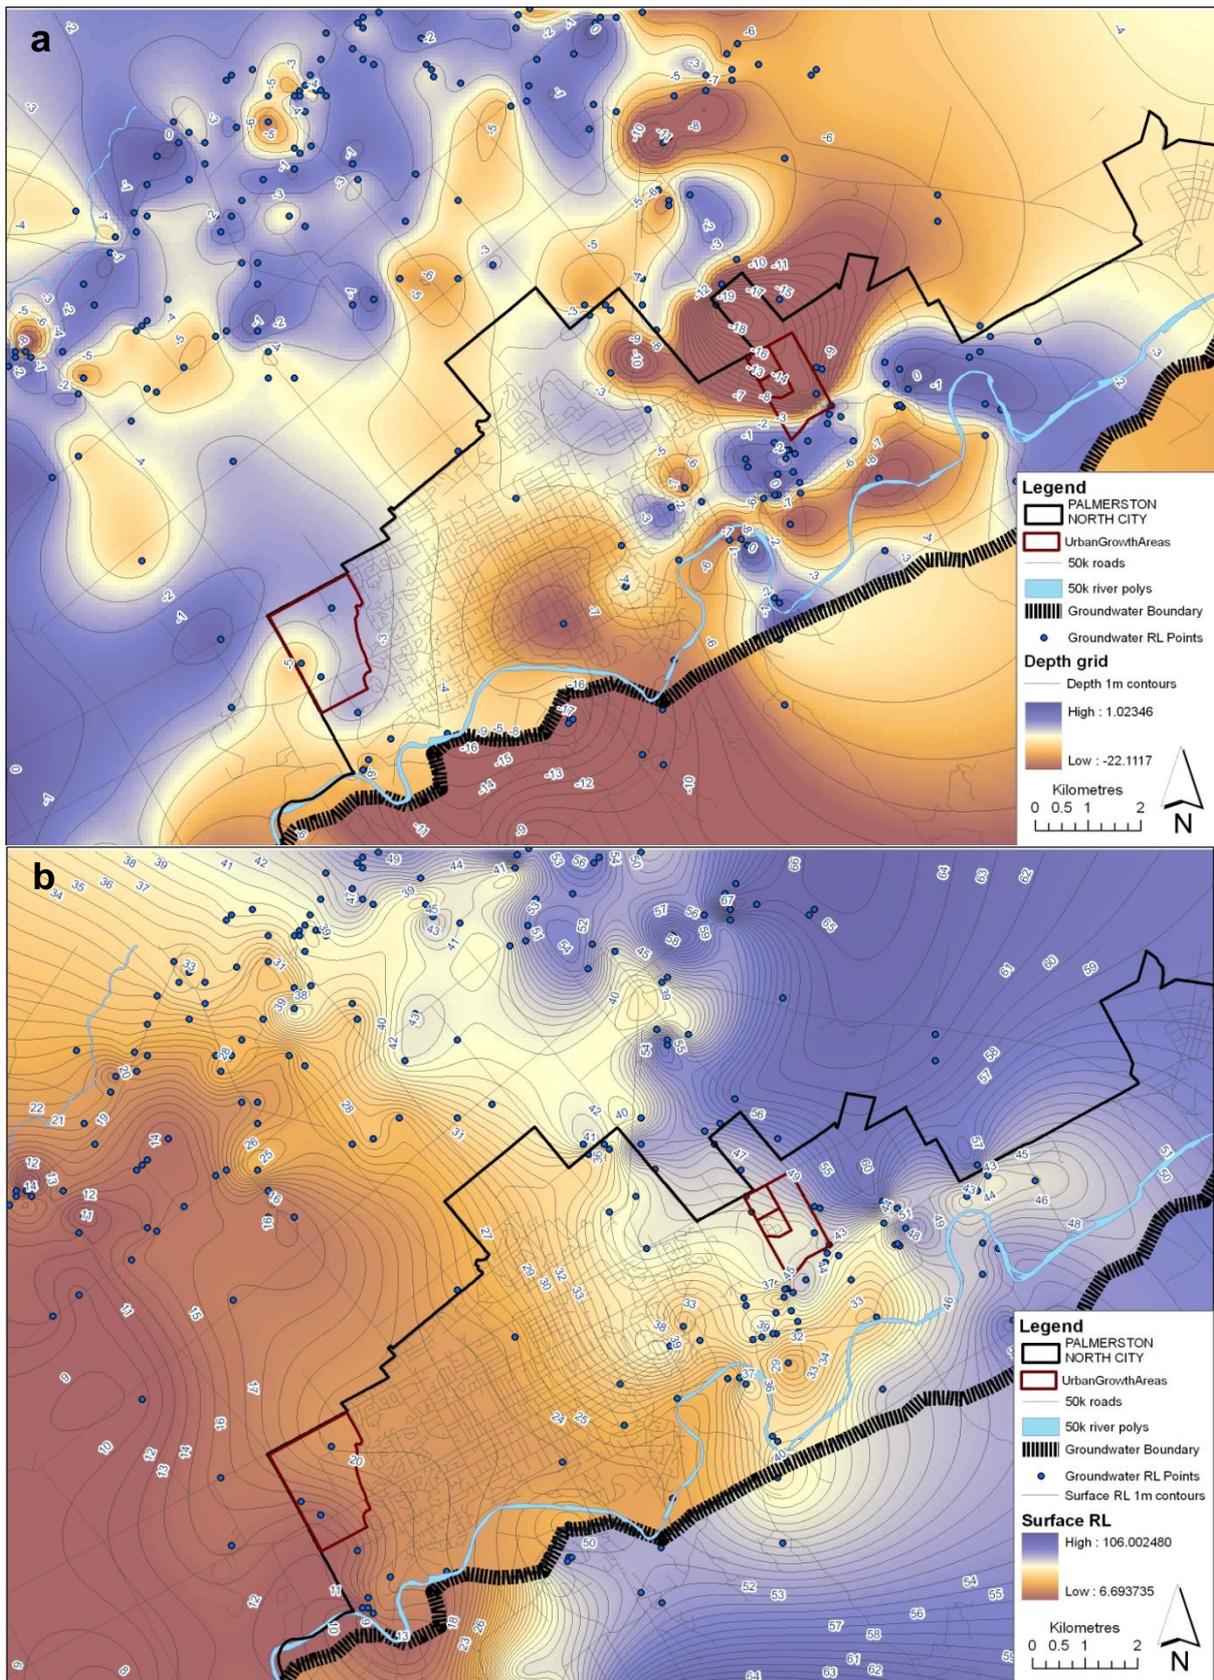
Figure 11 a) The modelled depth to groundwater in the Palmerston North City area showing point data available (depth and RL of groundwater surface). Modelled 1 m contours on the surface are labelled (depth in m to groundwater). b) The RL of the modelled groundwater surface, with data points in blue and labelled 1 m contours across the area.

The figures produced from the subsurface models (Figures 11 – 13, particularly Figure 13) provide an indication of where soil conditions favouring liquefaction may exist in the Palmerston North area. However, because of our interpretation and extrapolation of data, such indications have inherent inhomogeneities and errors. The entire area southeast of the Manawatu River has not been incorporated because the underlying materials here are last interglacial or older marginal marine and older alluvial deposits.

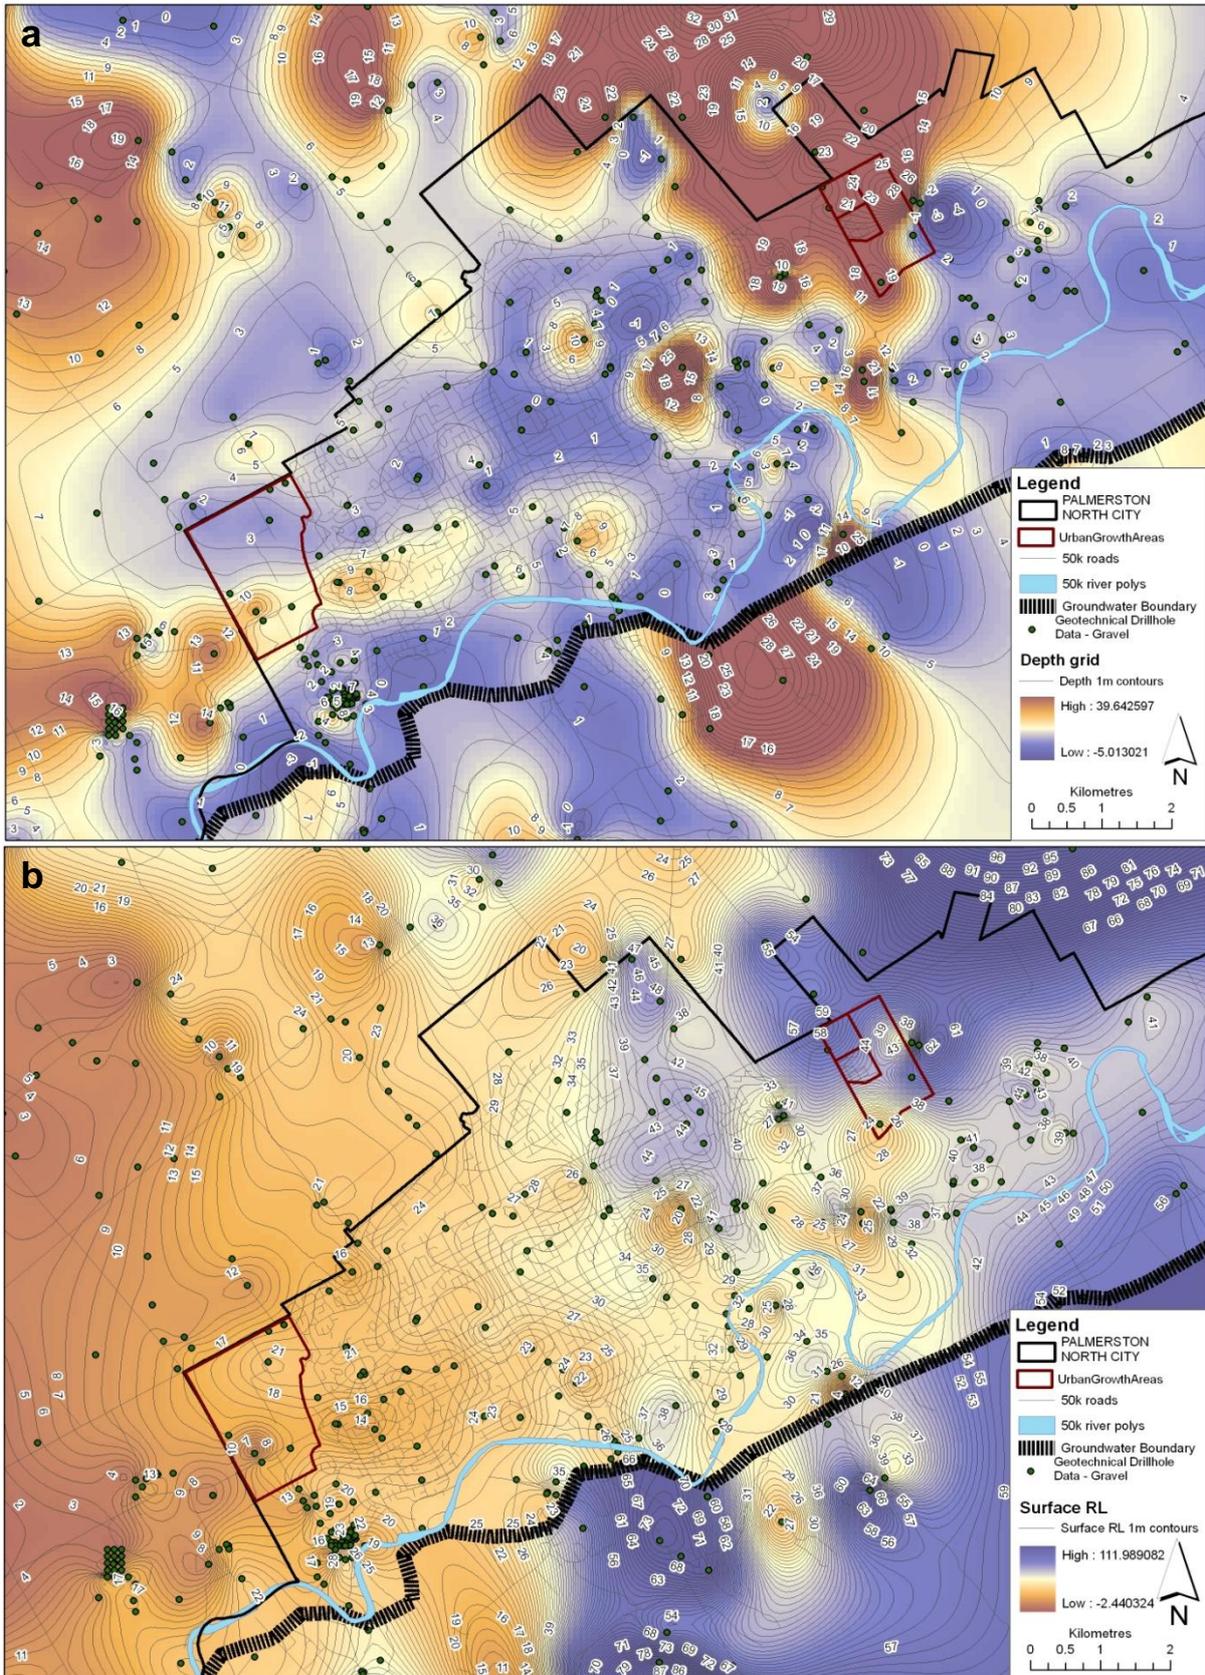
Figure 12 a) The modelled depth to the uppermost gravel unit in the Palmerston North City area. Data points (comb\_geotech\_drillhole\_depth\_to\_grav\_rl.shp) used to generate the model are shown as yellow points. 1 m contours indicate depth to the modelled surface. b) The modelled RL of the uppermost gravel surface with 1 m contours.

The modelled depth of “coverbeds” (Figures 12 & 13) suggests there may be a belt of thick soils across the southern one third of the area, up to 11 m thick. Static groundwater depths across the area are modelled at < 3 m across the eastern half. The modelled thickness of saturated “coverbeds” across the area varies from 0 to 7 m. Existing data suggest that there may be few liquefaction problems in the north-central part of the area (Westberg Rd/Whitehorse Dr area), but there may well be areas possibly susceptible to liquefaction near Pioneer Highway and Tremaine Ave. These characteristics provide a strong argument for exercising caution in development of this area. We recommend that comprehensive site investigations with good geotechnical advice precede development. A major lesson from the Canterbury earthquakes damage is that provided houses and buildings are constructed on foundations that take account of local site subsurface conditions and continue to provide support when the foundation soils yield, deform inelastically, and/or liquefy, then the houses and buildings can survive undamaged. Measures can also be taken to minimise damage to infrastructure, such as buried pipelines.

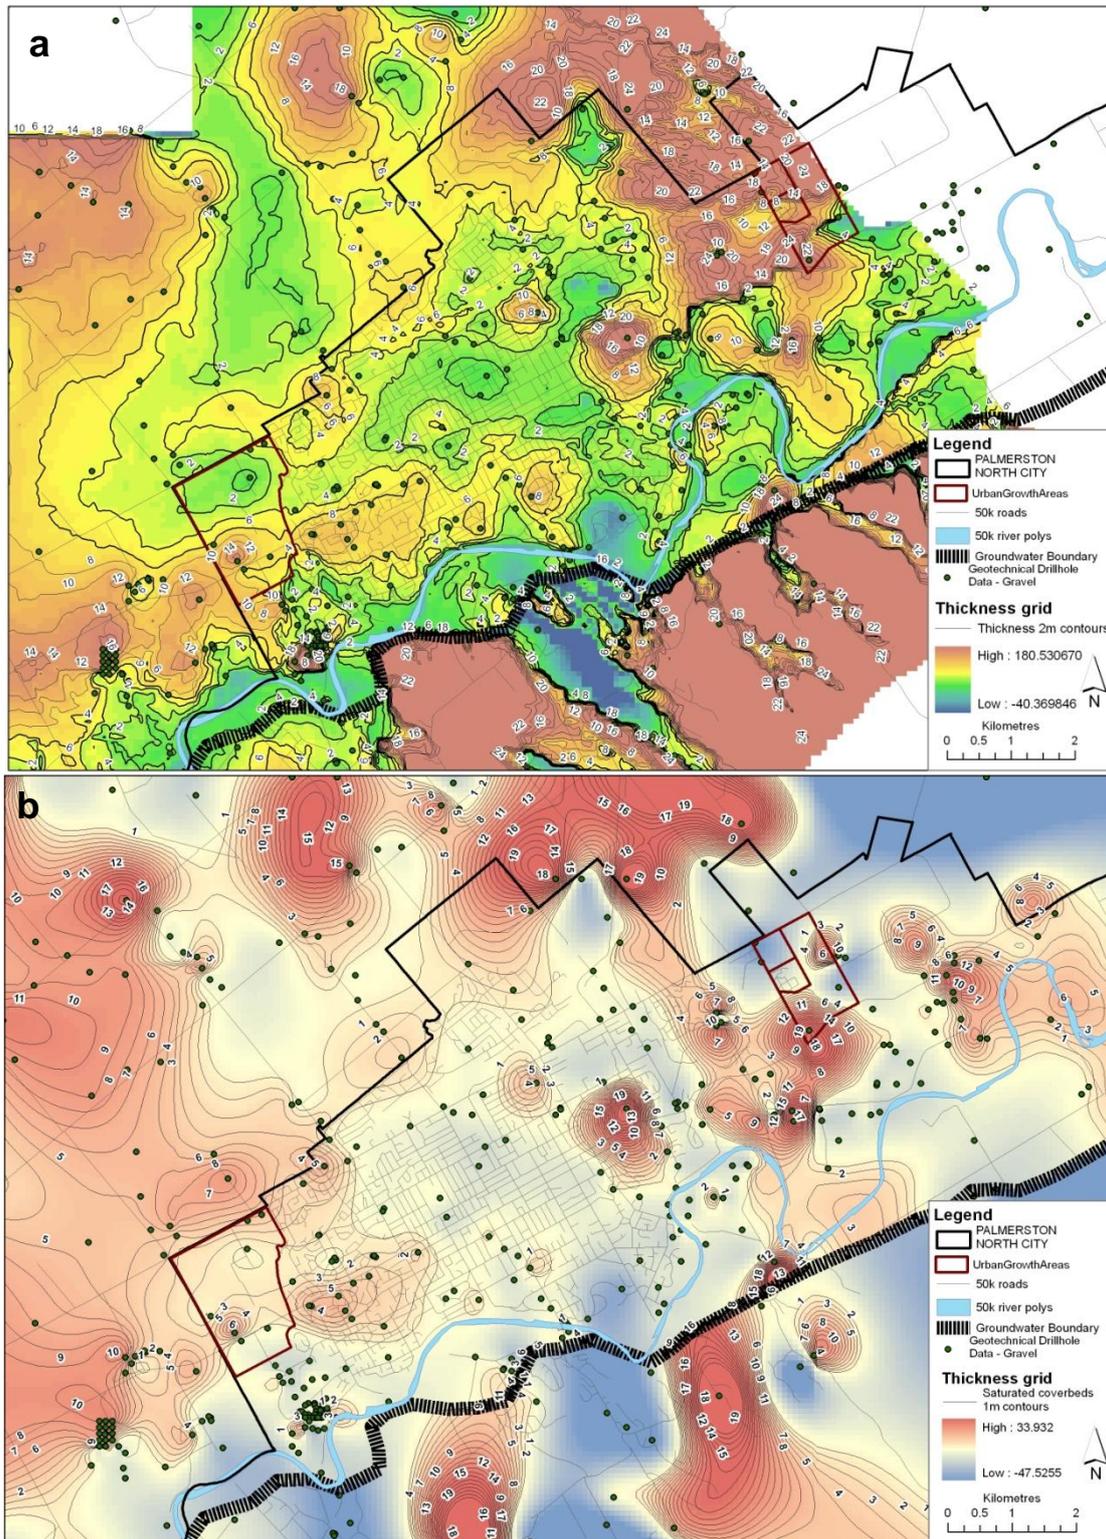
Figure 13 a) The modelled thickness of cover deposits upon the topmost gravel in the Palmerston North City area. One m contours are shown where positive values less than 20 m are indicated. High positive values are assumed to represent areas where gravel is deep and presumably materials are older marine Quaternary deposits. b) The modelled thickness of saturated cover materials (on gravel) that may have high liquefaction susceptibility. Two metre contours are present in areas that have thick cover sequences that may have high liquefaction susceptibility. Yellow areas are underlain by thin saturated cover materials.

When combined, these data provide a significant amount of information useful in quantifying liquefaction potential. The lidar data provides a very accurate topographic model, and assists in interpreting the Holocene (last 10,000 years) depositional environments across the area (e.g. Figure 13 & 14).

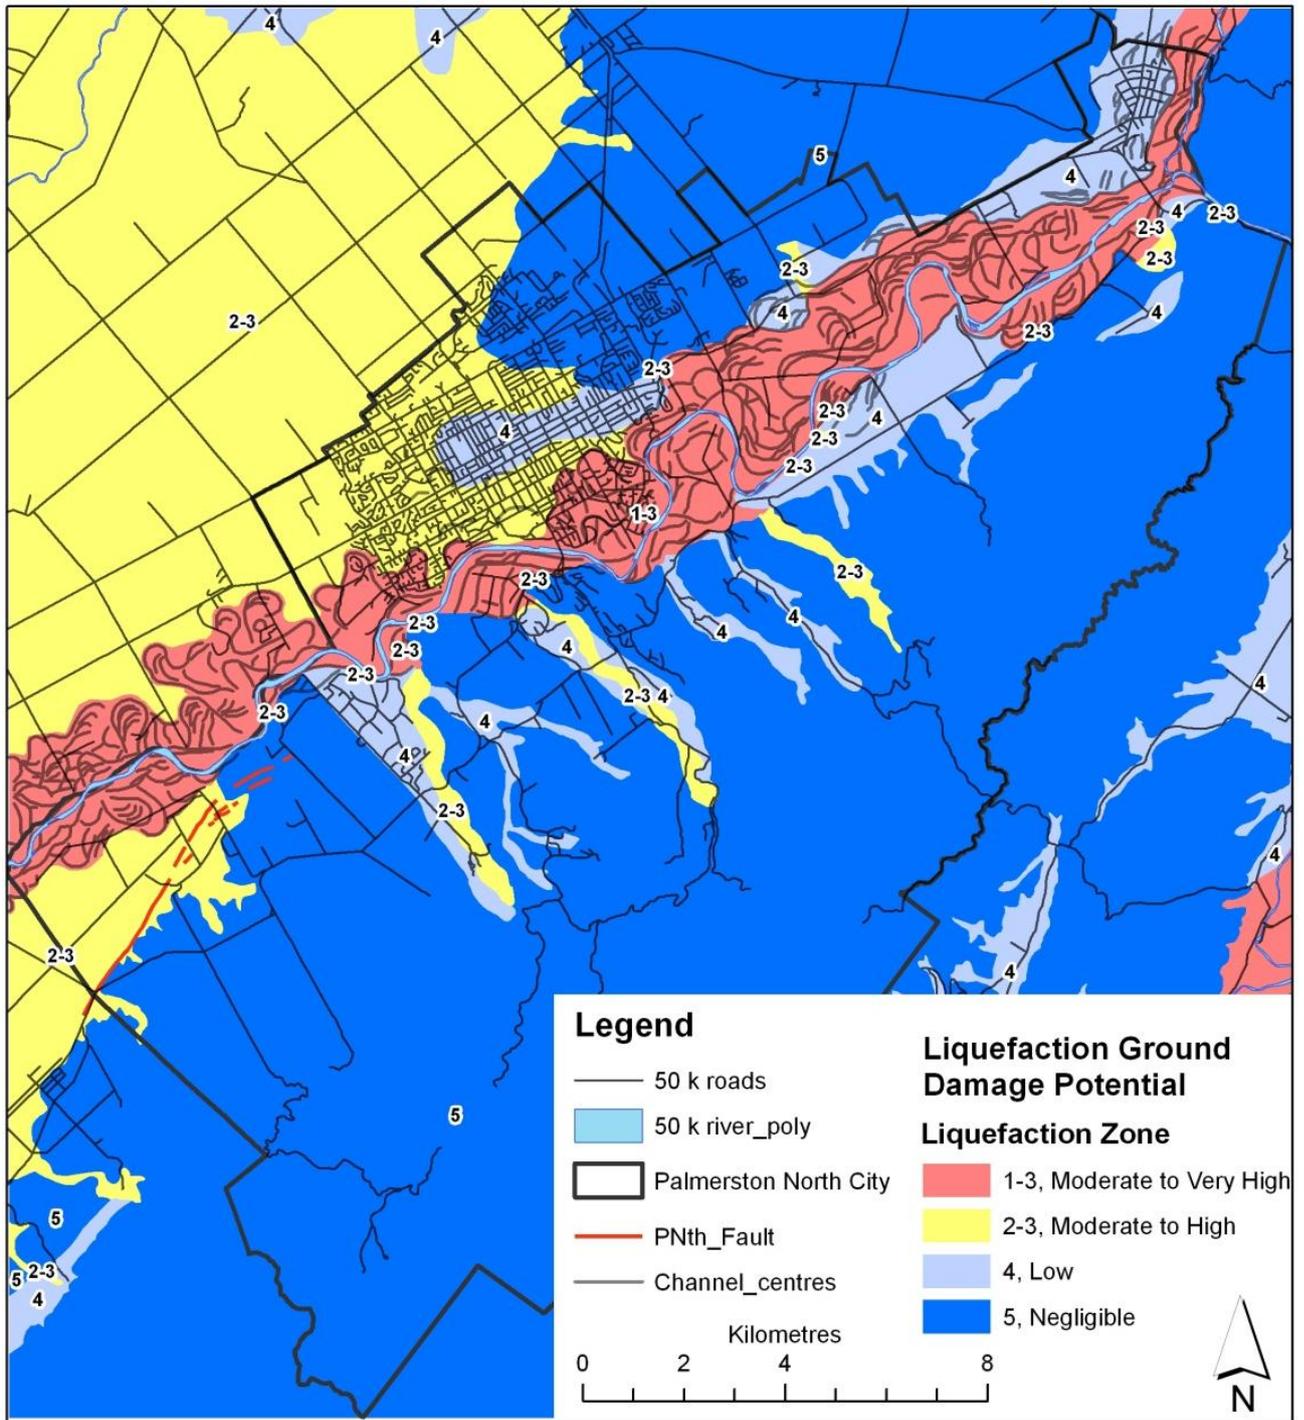
Figure 14 Enlarged version of the liquefaction ground damage potential map developed in this report.

- 1. = Very High Liquefaction Ground Damage Potential
- 2. = High Liquefaction Ground Damage Potential
- 3. = Moderate Liquefaction Ground Damage Potential
- 4. = Low Liquefaction Ground Damage Potential
- 5. = Negligible Liquefaction Ground Damage Potential

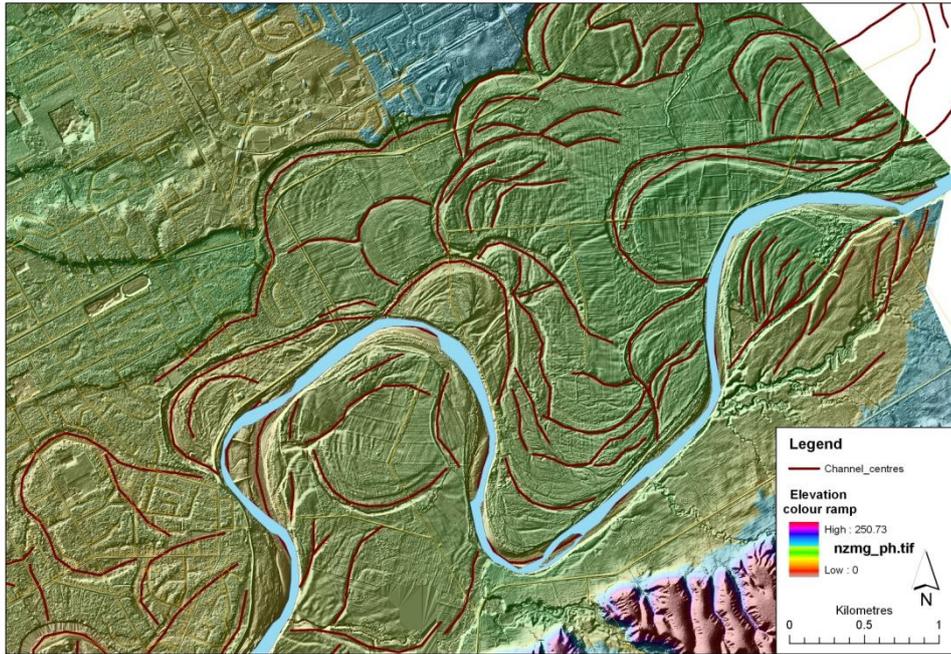
Figure 15 Palmerston North City lies adjacent to the late Holocene floodplain of the Manawatu River. The Lidar DEM allows a far more accurate definition of the active late Holocene floodplain which is characterised by densely spaced, partially infilled alluvial channel features.

The active floodplain of the Manawatu River is characterised by relict sinuous alluvial channel forms of the late Holocene Manawatu River (Figure 15). The depth of well-preserved channels on the floodplain ranges from < 2 m to c. 5 m.

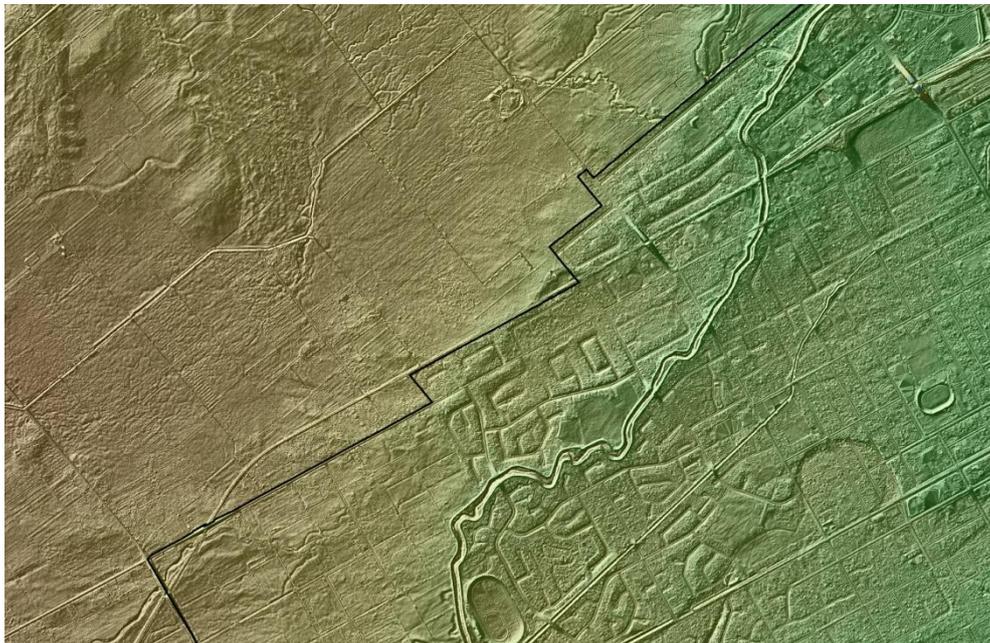
Figure 16 Detailed colour ramped DEM of the western part of Palmerston North City illustrating the presence and extent of levee-ed stream systems on this part of the Manawatu Plains. The main stream, Mangaone Stream, is contained behind man-made stop-banks. The trotting track is at the lower centre of the image.

The Lidar DEM and derivative hillshades show that much of the area previously described as the Manawatu Plains (Begg & Johnston 2000) consists of late Holocene levee-ed stream systems and their associated deposits (Figure 16). The perching elevation of such levee-ed streams above the surrounding plains ranges from c. 2m to c. 5 m.

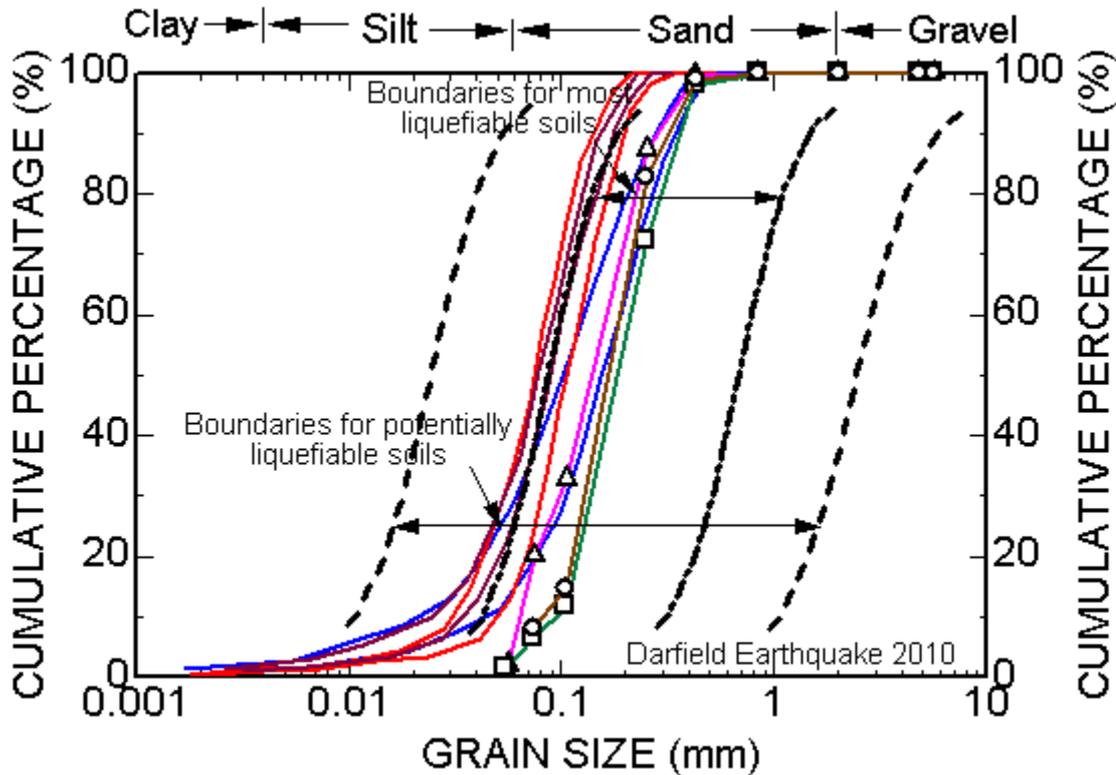
1. An example showing grading curves for liquefied soils from Christchurch. Samples taken after the Darfield Earthquake. These grading curves represent very highly liquefiable soils.

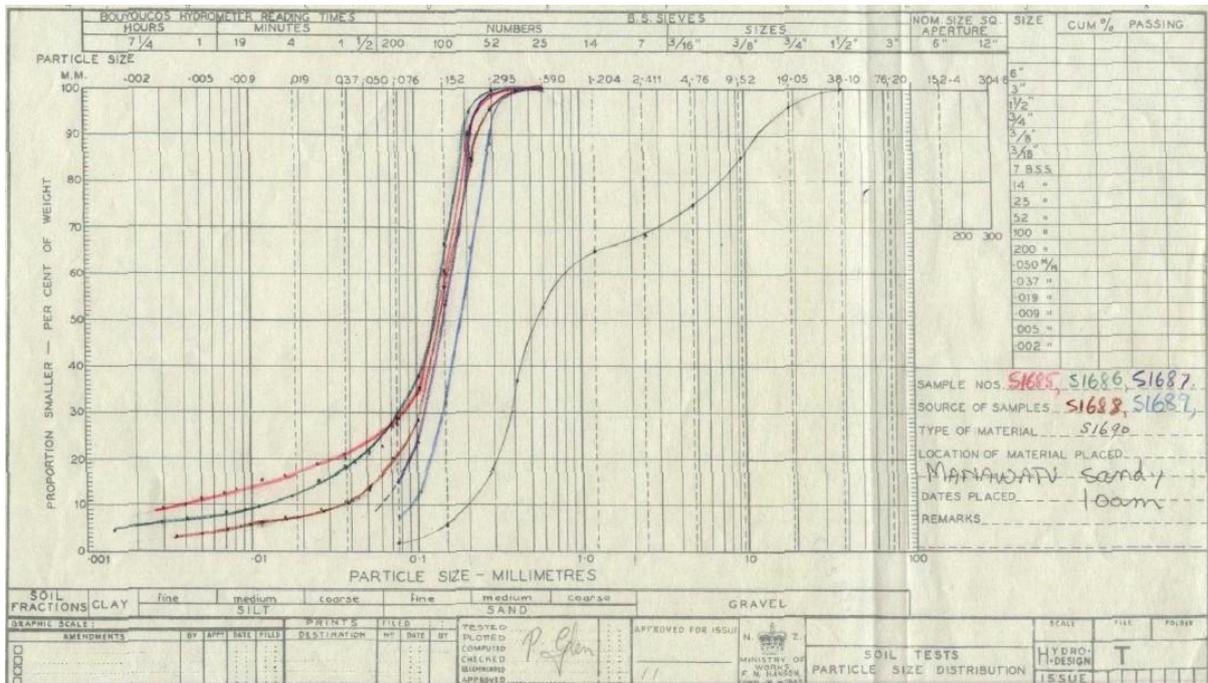
2. Manawatu Sandy Loam. Most samples have steep, uniform grading curves indicating very high liquefaction susceptibility. Such soils will liquefy when saturated.

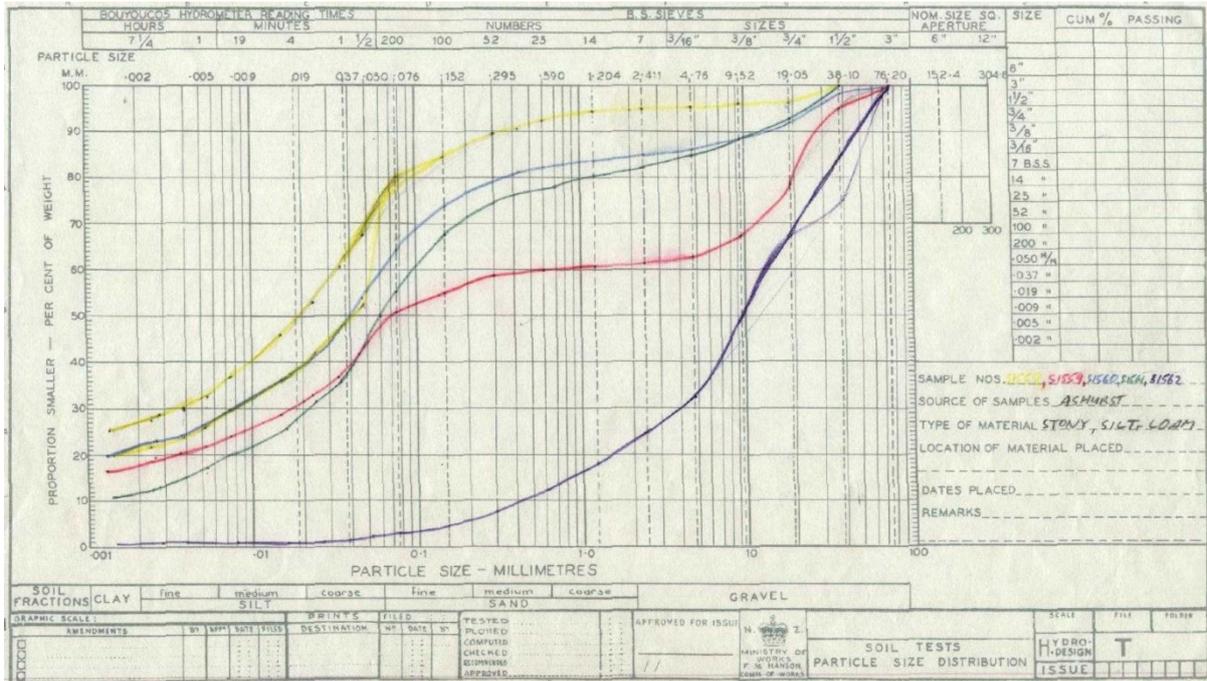
**3. Ashurst stony silt loam.** These grading curves indicate well graded soils with negligible liquefaction susceptibility.

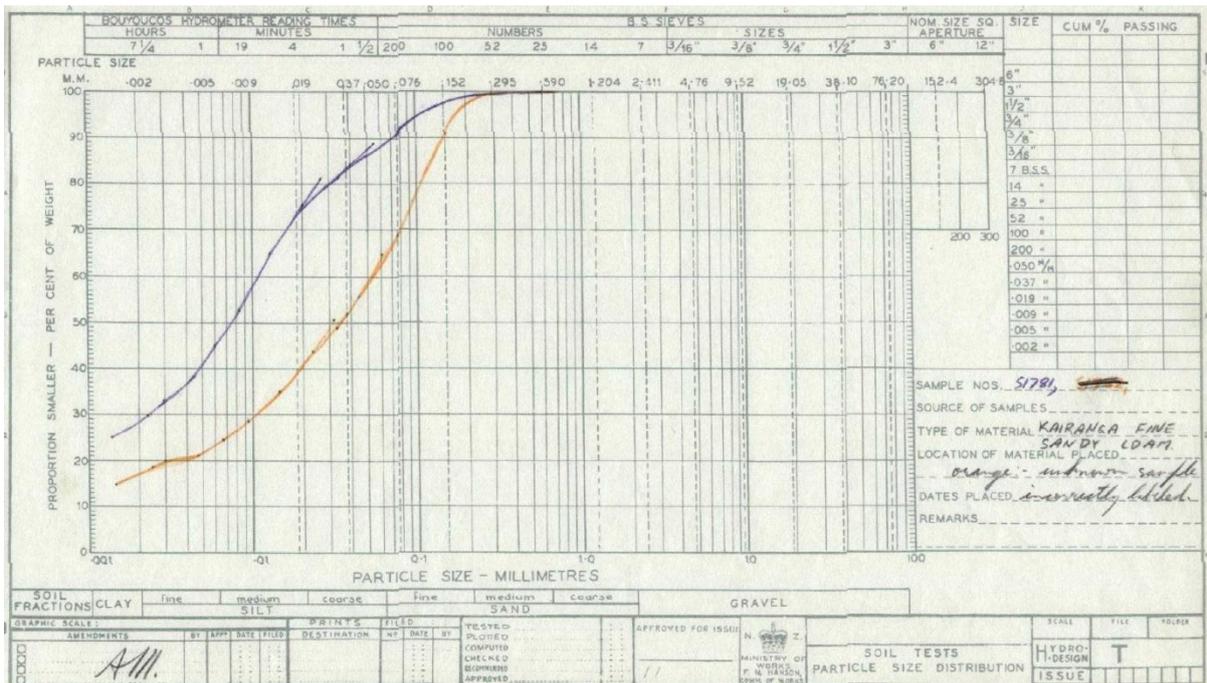
**4. Kairanga fine sandy loam.** These grading curves have ~20% fines which will tend to fill pore spaces. They are generally outside the range of susceptible soils.

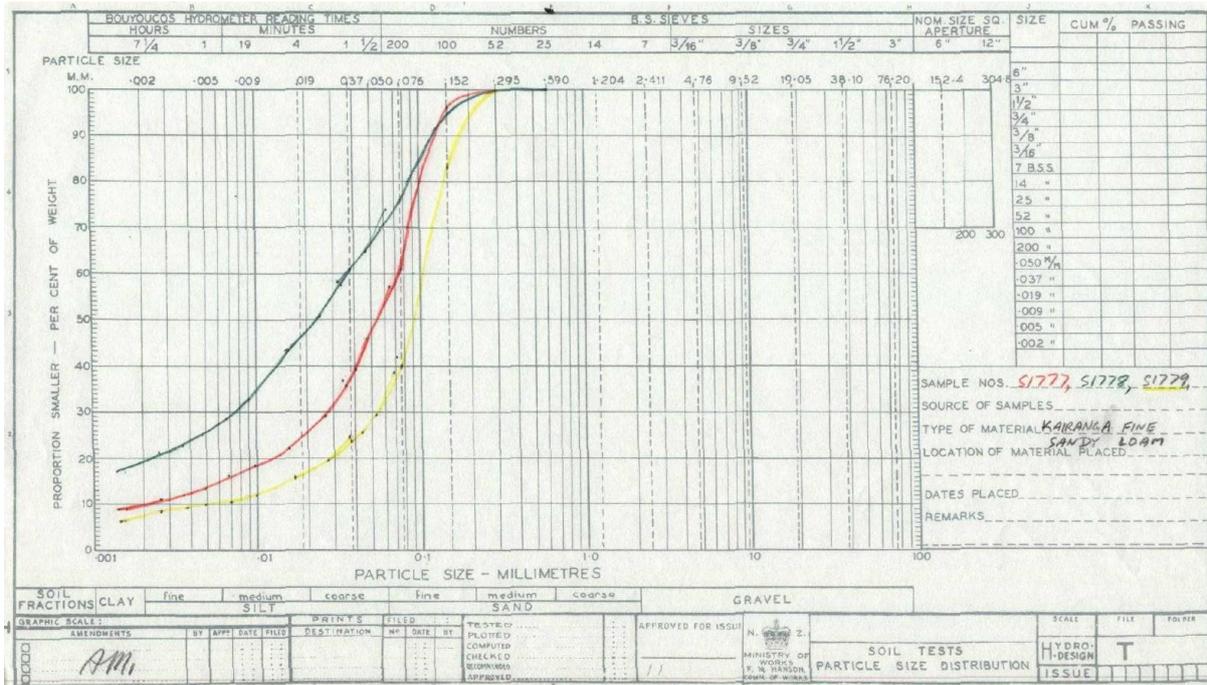
**5. Kairanga fine sandy loam.** The red and yellow curves are likely to be susceptible to liquefaction. The Kairanga soils have negligible to moderate liquefaction potential.

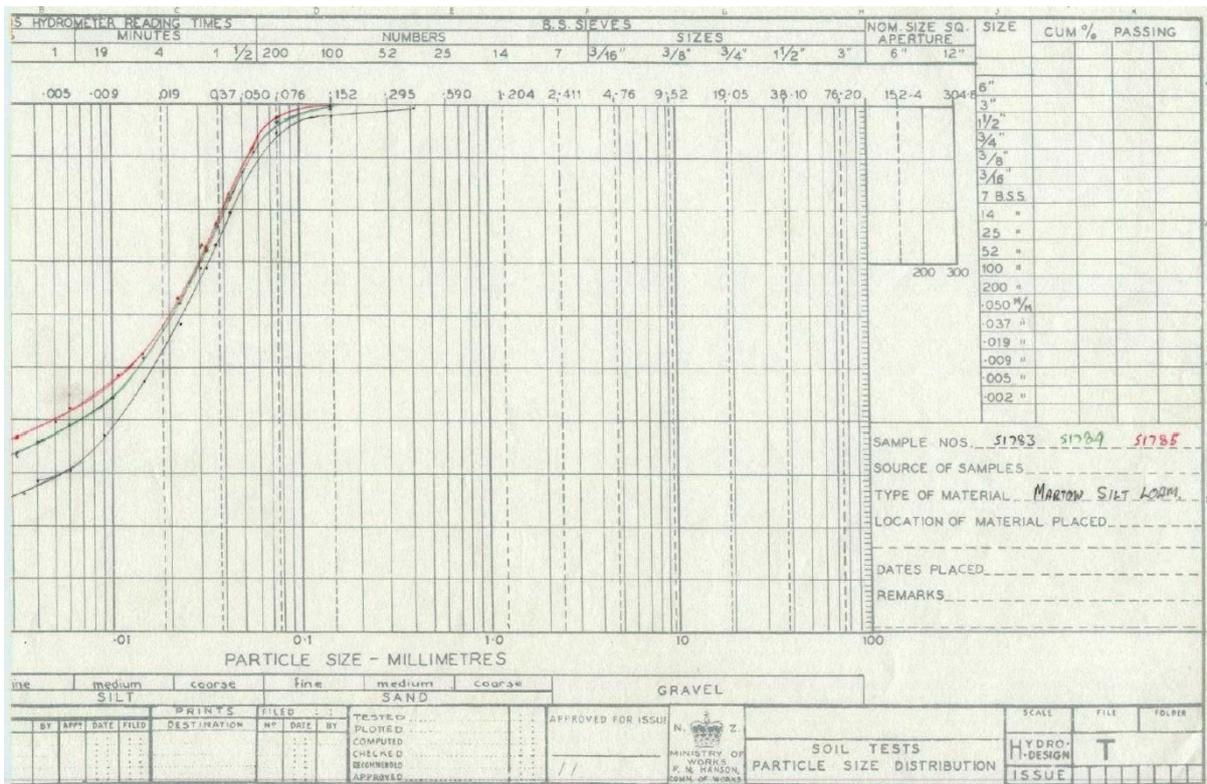
**6. Marton silt loam.** These curves are outside the range of liquefiable soils (see 1 above) and have a high (~30%) fines content. They have negligible liquefaction potential.

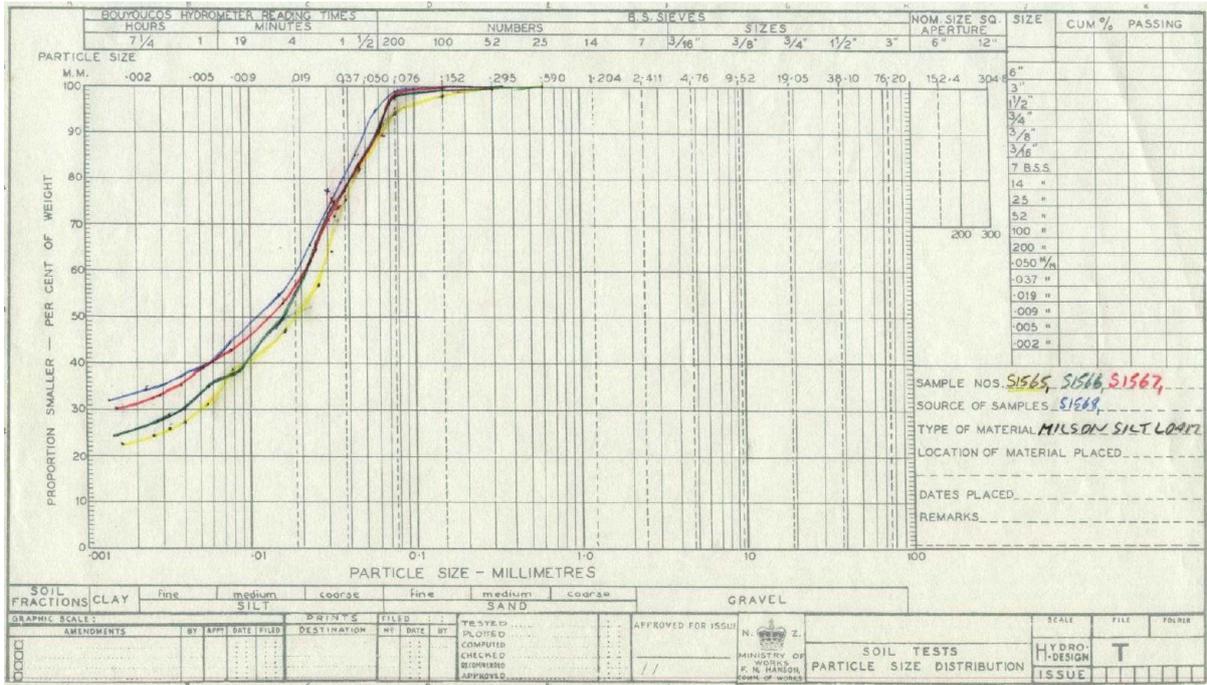
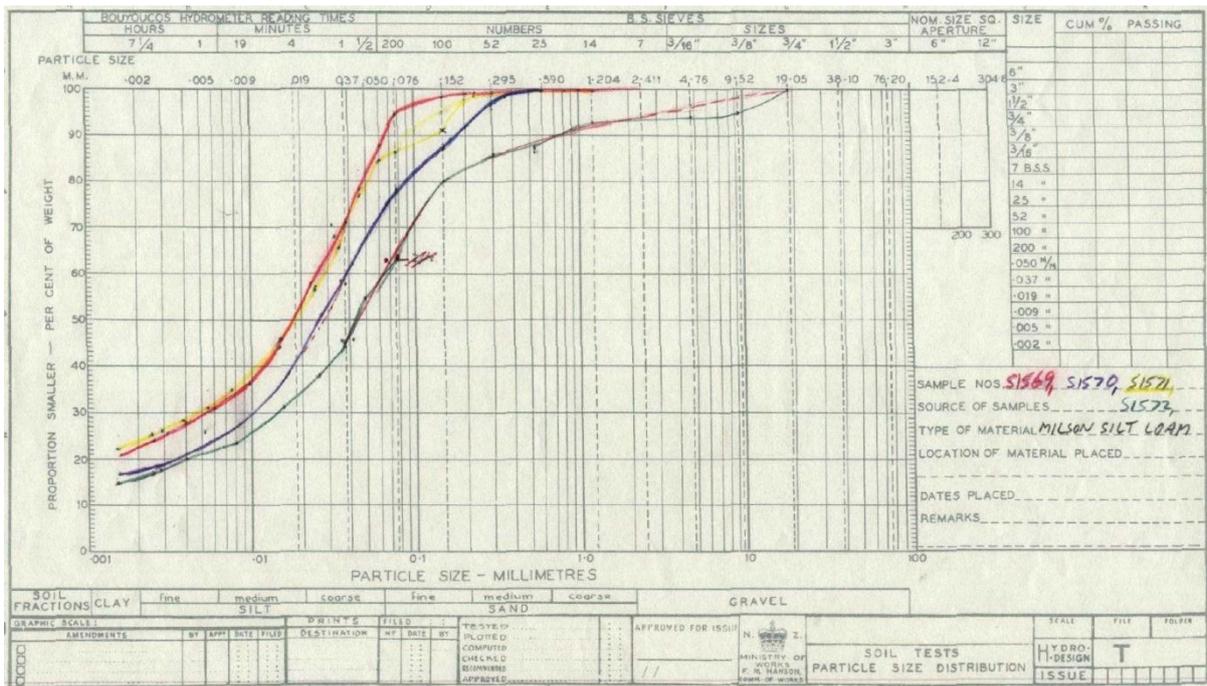
7.

8. Curves 7 & 8 are Milson silt loam. They are outside the range of liquefiable soils and have negligible liquefaction potential.

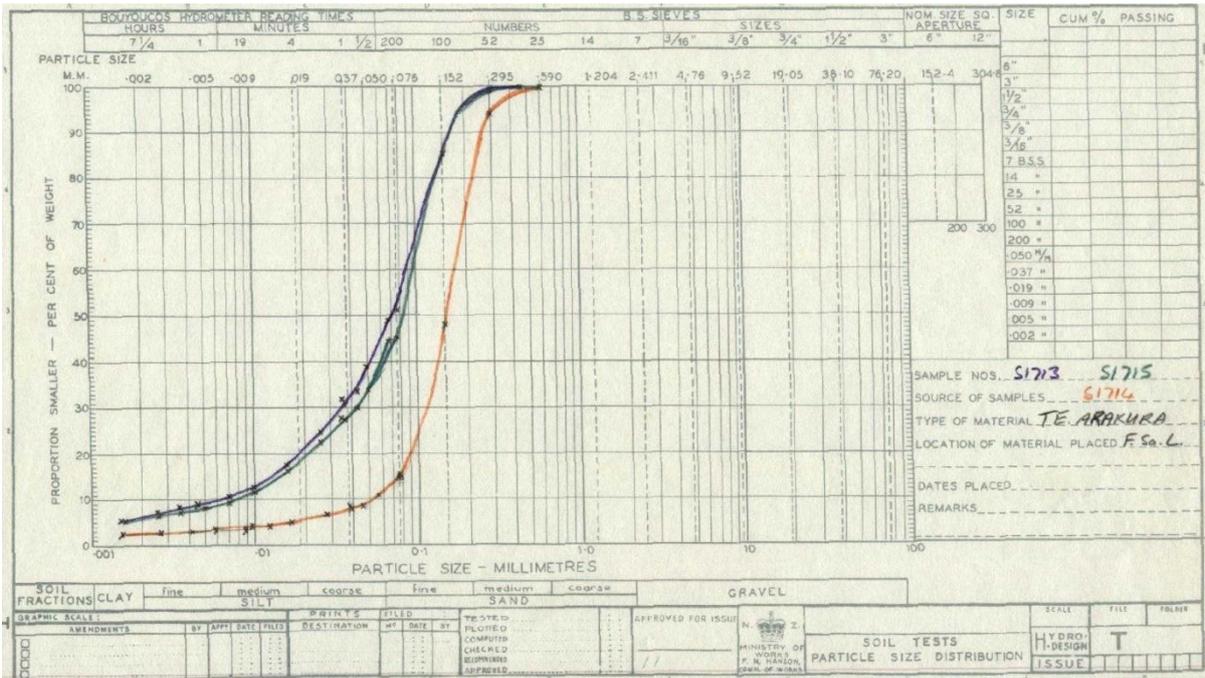
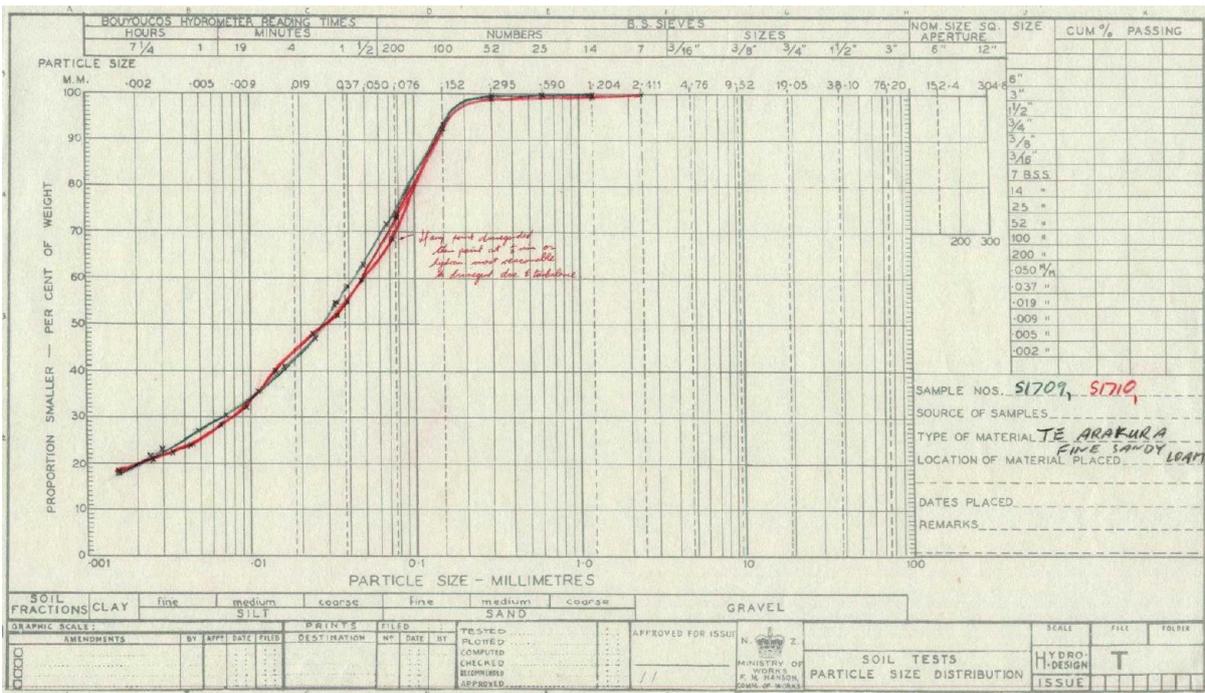
10. Curves 9 & 10 are TeArakura fine sand. Curves 9 show liquefaction susceptibility whereas 10 do not. We conservatively regard the TeArakura fine sand to be moderately to highly susceptible to liquefaction.
