**Assessment of liquefaction and related ground  
failure hazards in Palmerston North, New Zealand**

**GNS Science Consultancy Report 2011/108  
July 2011**

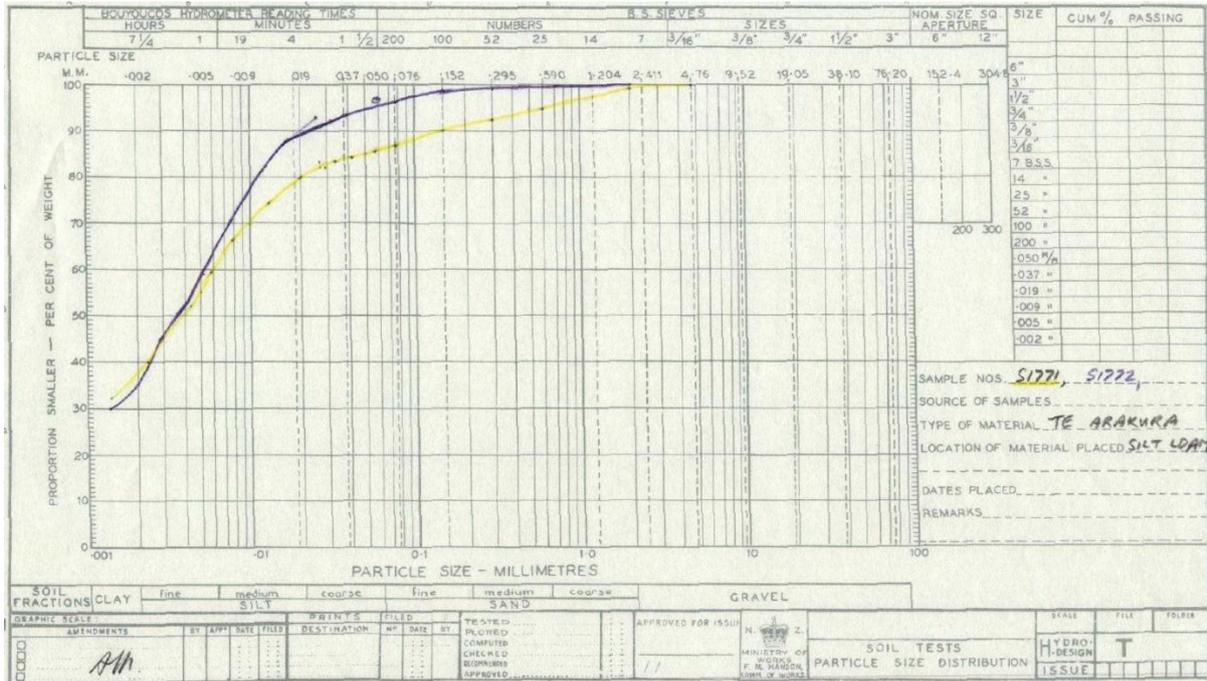
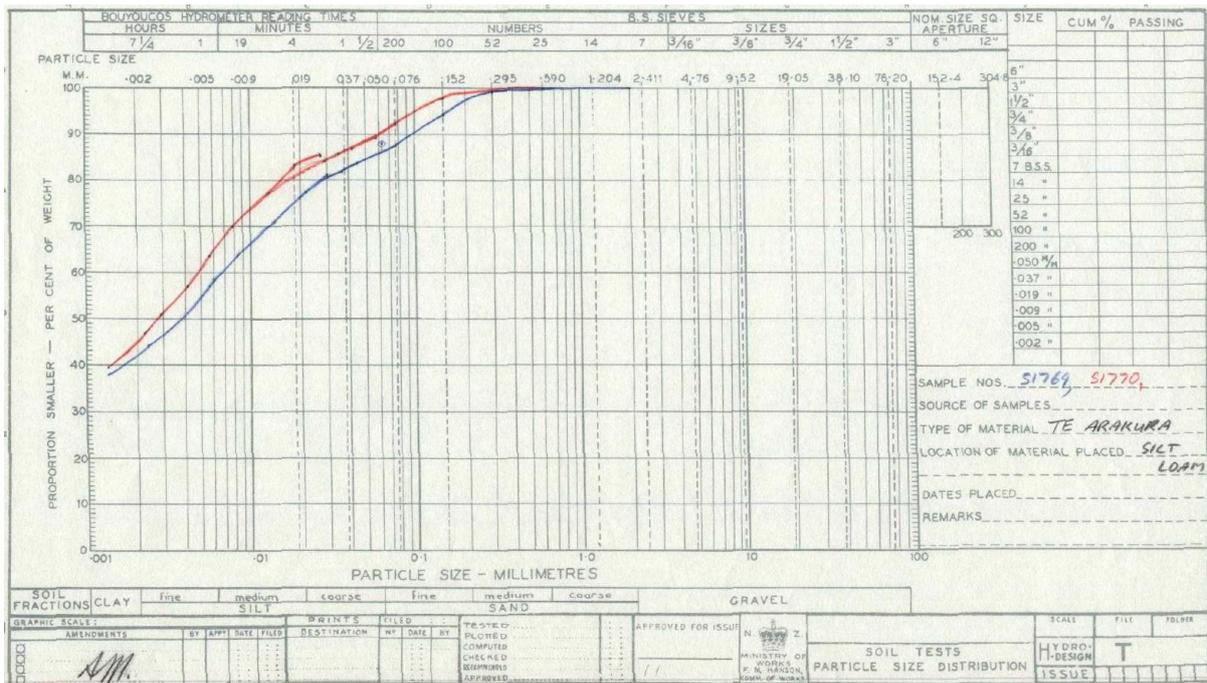
11.

12. Curves 11 & 12 are TeArakura silt loam. These soils have a high fines content and are outside the range of liquefiable soils. They have negligible liquefaction susceptibility.
