How Safe Is "Safe" - The Journey of PNCC as a "Small" Owner of Two Large Dams

Dora Luo Palmerston North City Council

Abstract –

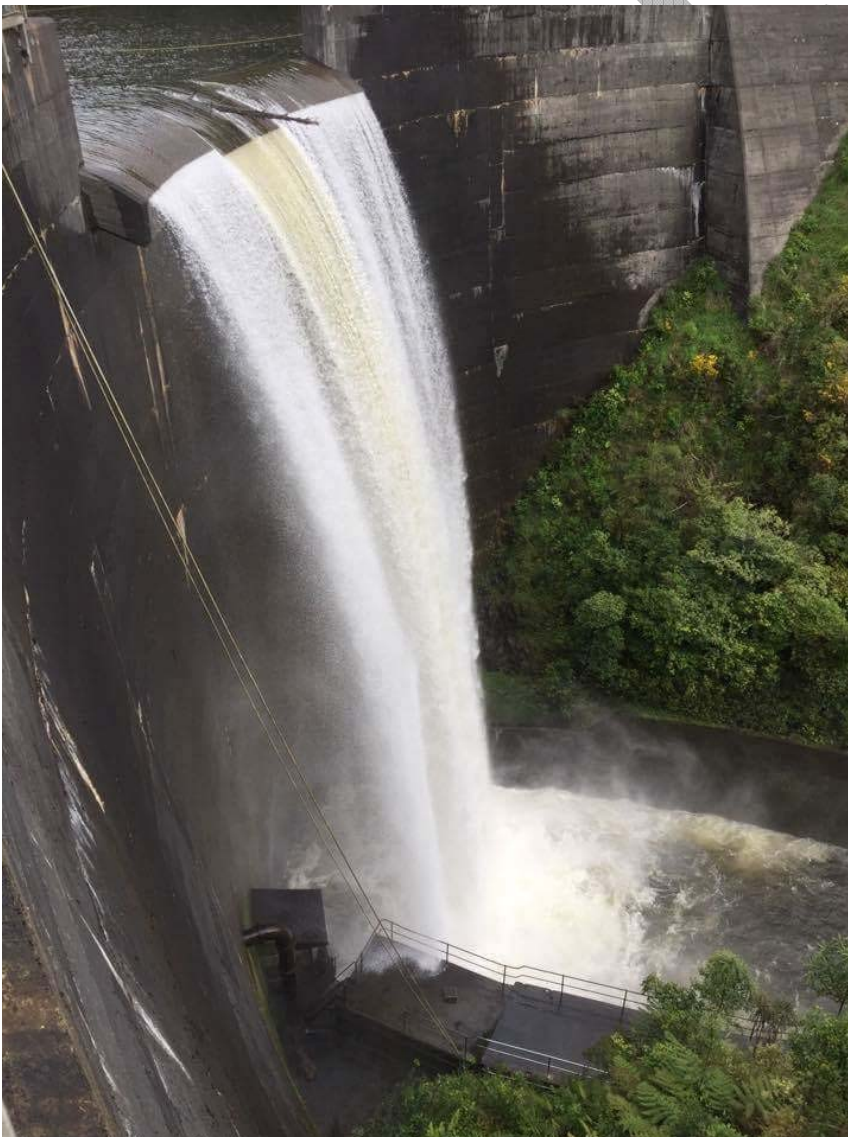
Figure 2, Turitea Upper Dam when is overflowing

Upper Turitea Dam is a variable radius arch dam with a gravity thrust block on the upper left Abutment built in 1957. It is the largest dam in New Zealand for the same sort.

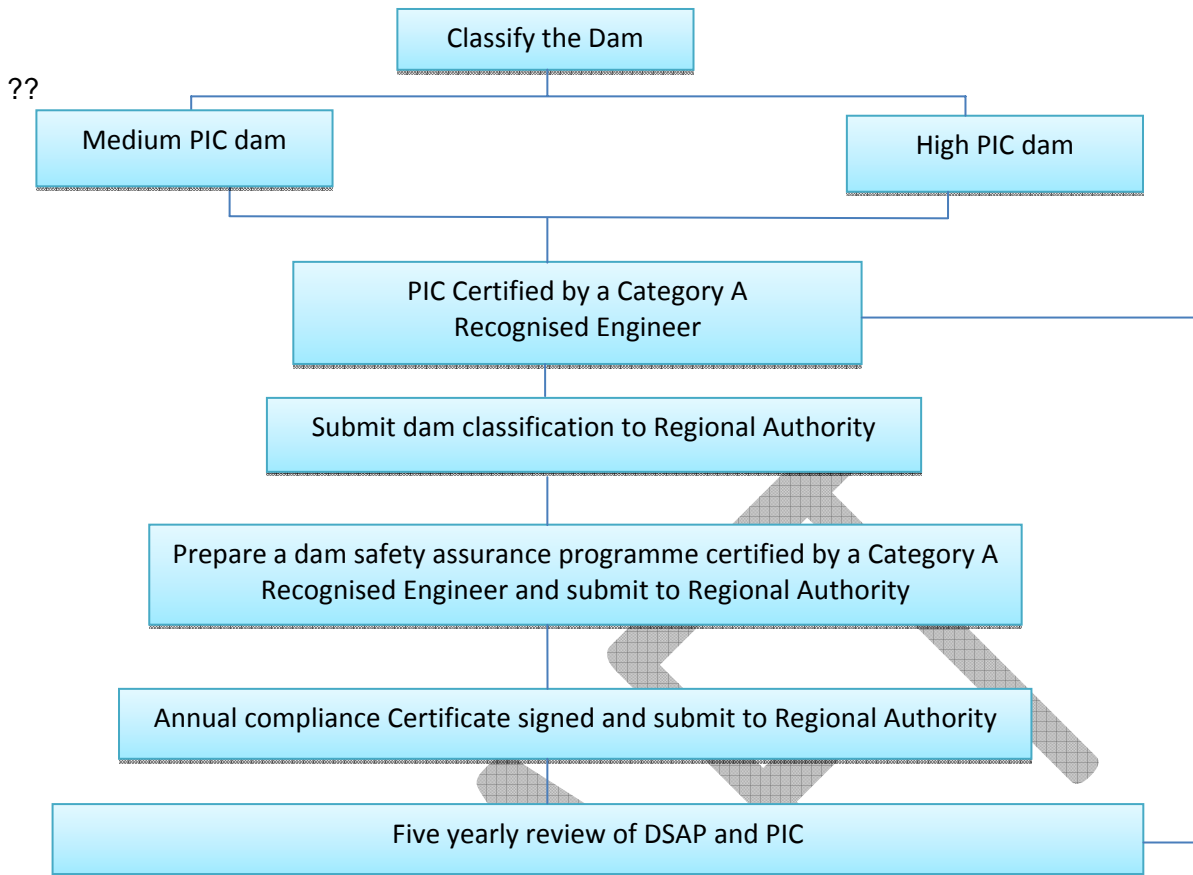
- Surveillance – what and how often
- Annual dam safety review (ADSR)
- Comprehensive dam safety review (CDSR)
- Emergency Action Plan
- Appurtenant structures – inspection exercise and testing
- Deficiencies management - investigation, assessment and resolution

A flow chart shows the requirements of the Scheme for High and Medium Dams is shown as below:
